PROBLEM SUMMARY

Area
Store 8 - Pikeville [140780]
Machine Id
KLEEMANN MC100Ri K011.0035
Component
Hydraulic System
Fluid
WIRTGEN GROUP HYDRAULIC OIL HVLP 46 (58 GAL)

OIL ANALYSIS REPORT

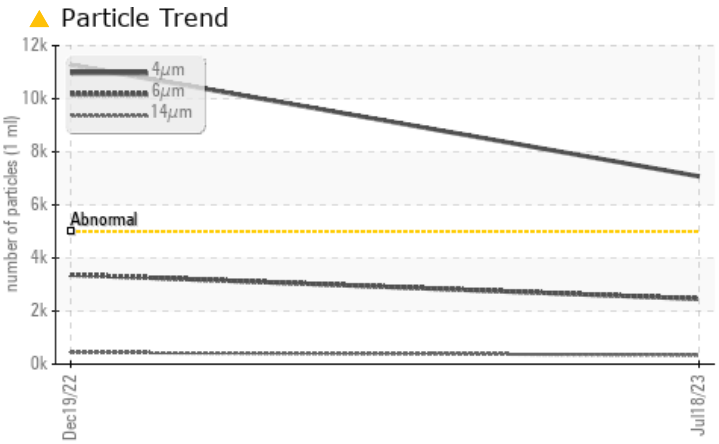
COMPONENT CONDITION SUMMARY

Sample Status				**ABNORMAL**	ABNORMAL	---
Particles >4µm		ASTM D7647	>5000	▲ **7075**	▲ 11274	---
Particles >6µm		ASTM D7647	>1300	▲ **2462**	▲ 3371	---
Particles >14µm		ASTM D7647	>160	▲ **342**	▲ 441	---
Particles >21µm		ASTM D7647	>40	▲ **135**	▲ 140	---
Particles >38µm		ASTM D7647	>10	▲ **12**	▲ 15	---
Particles >71µm		ASTM D7647	>3	▲ **2**	1	---
Oil Cleanliness		ISO 4406 (c)	>19/17/14	▲ **20/18/16**	▲ 21/19/16	---

Contamination
There is a high amount of particulates present in the oil.

No corrective action is recommended at this time. The filter change at the time of sampling has been noted. Resample at the next service interval to monitor.

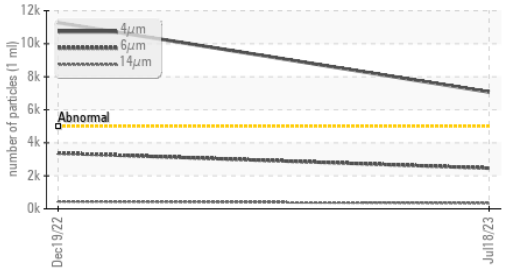
Particle Trend

FLUID CLEANLINESS		method	limit/base	current	history1	history2
Particles >4µm		ASTM D7647	>5000	▲ **7075**	▲ 11274	---
Particles >6µm		ASTM D7647	>1300	▲ **2462**	▲ 3371	---
Particles >14µm		ASTM D7647	>160	▲ **342**	▲ 441	---
Particles >21µm		ASTM D7647	>40	▲ **135**	▲ 140	---
Particles >38µm		ASTM D7647	>10	▲ **12**	▲ 15	---
Particles >71µm		ASTM D7647	>3	▲ **2**	1	---
Oil Cleanliness		ISO 4406 (c)	>19/17/14	▲ **20/18/16**	▲ 21/19/16	---

Recommendation
No corrective action is recommended at this time. The filter change at the time of sampling has been noted. Resample at the next service interval to monitor.

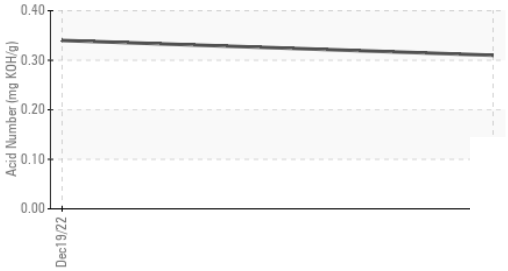
Acid Number

Fluid Condition
The AN level is acceptable for this fluid. The condition of the oils additive package is suitable for further service.

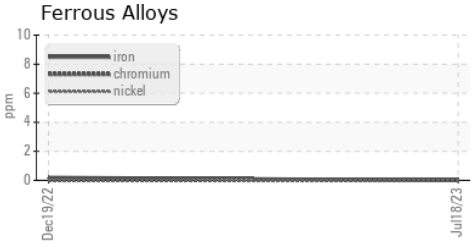
Ferrous Alloys

Wear
All component wear rates are normal.
