Machine Id
1834135 (S/N 1002)
Component
Compressor
Fluid
KAESER SIGMA (OEM) M-460 (--- GAL)

Customer Id: BRISANCA
Sample No.: KCP35053
Lab Number: 05904399
Test Package: IND 2

OIL ANALYSIS REPORT

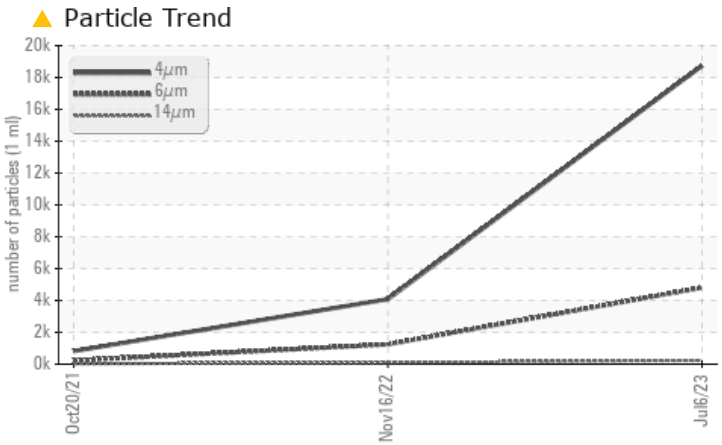
COMPONENT CONDITION SUMMARY

Sample Status				ABNORMAL	ATTENTION	ABNORMAL
Particles >6µm		ASTM D7647	>1300	▲ **4800**	1239	227
Particles >14µm		ASTM D7647	>80	▲ **227**	▲ 98	23
Particles >21µm		ASTM D7647	>20	▲ **54**	▲ 21	5
Oil Cleanliness		ISO 4406 (c)	>--/17/13	▲ **21/19/15**	▲ 19/17/14	15/12

Contamination
There is a high amount of particulates present in the oil.

No corrective action is recommended at this time. The filter change at the time of sampling has been noted. Resample at the next service interval to monitor.

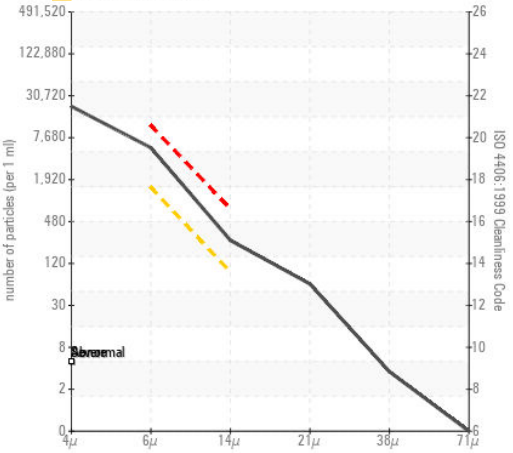
Particle Count

FLUID CLEANLINESS		method	limit/base	current	history1	history2
Particles >4µm		ASTM D7647		**18739**	4078	819
Particles >6µm		ASTM D7647	>1300	▲ **4800**	1239	227
Particles >14µm		ASTM D7647	>80	▲ **227**	▲ 98	23
Particles >21µm		ASTM D7647	>20	▲ **54**	▲ 21	5
Particles >38µm		ASTM D7647	>4	**3**	2	0
Particles >71µm		ASTM D7647	>3	**0**	0	0
Oil Cleanliness		ISO 4406 (c)	>--/17/13	▲ **21/19/15**	▲ 19/17/14	15/12
