OIL ANALYSIS REPORT

Machine Id
335 - EFFECT 6 LIQUOR TRANSFER
Component
Pump
Fluid
MOBIL SHC 626 (1 GAL)

FERROGRAPHY REPORT

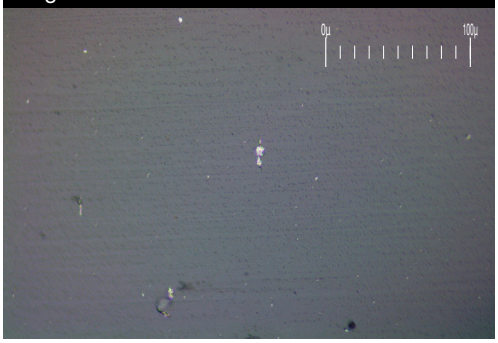
Magn: 500x Illum: RW

All component wear rates are normal. The analytical ferrographic results are normal indicating no abnormal wear in the system.
