Customer Id: AVEMIL
Sample No.: WC05905407
Lab Number: 05905407
Test Package: IND 2

OIL ANALYSIS REPORT

Machine Id
T-102
Component
Agitator Gearbox
Fluid
GEAR OIL ISO 320 (--- GAL)

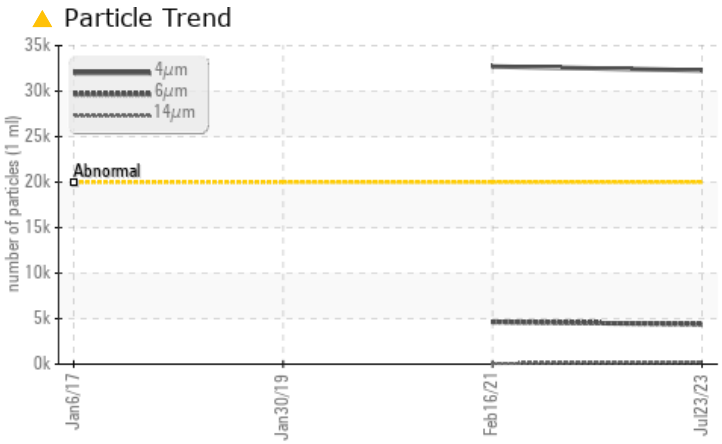
COMPONENT CONDITION SUMMARY

ATTENTION	ATTENTION	NORMAL
Sample Status				**ATTENTION**	ATTENTION	NORMAL
Particles >4µm		ASTM D7647	>20000	▲ **32277**	▲ 32707	---
Oil Cleanliness		ISO 4406 (c)	>21/19/16	▲ **22/19/15**	▲ 22/19/13	---

Contamination
There is a moderate amount of silt (particulates < 14 microns in size) present in the oil.

No corrective action is recommended at this time.
Resample at the next service interval to monitor.

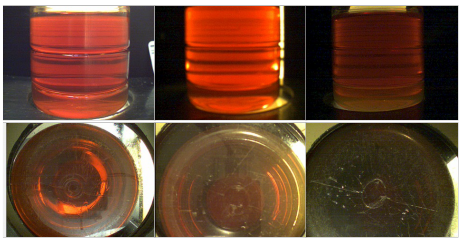
SAMPLE IMAGES	method	limit/base	current	history1	history2
Color					
Bottom

VISUAL		method	limit/base	current	history1	history2
White Metal	scalar	*Visual	NONE	**NONE**	NONE	NONE
Yellow Metal	scalar	*Visual	NONE	**NONE**	NONE	NONE
Precipitate	scalar	*Visual	NONE	**NONE**	NONE	NONE
Silt	scalar	*Visual	NONE	**NONE**	NONE	NONE
Debris	scalar	*Visual	NONE	**NONE**	NONE	NONE
Sand/Dirt	scalar	*Visual	NONE	**NONE**	NONE	NONE
Appearance	scalar	*Visual	NORML	**NORML**	NORML	NORML
Odor	scalar	*Visual	NORML	**NORML**	NORML	NORML
Emulsified Water	scalar	*Visual	>0.1	**NEG**	NEG	NEG
Free Water	scalar	*Visual		**NEG**	NEG	NEG
