Machine Id
TE2 (S/N 1738)
Component
Agitator Gearbox
Fluid
MOBIL MOBILGEAR 630 (5 GAL)

Customer Id: AVEMIL
Sample No.: WC05905422
Lab Number: 05905422
Test Package: IND 2

OIL ANALYSIS REPORT

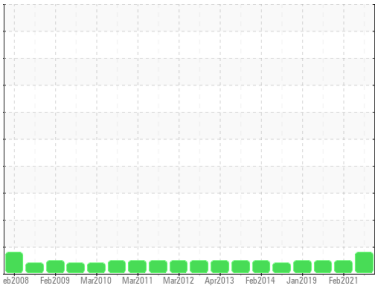
Sample Rating Trend

SEDIMENT

We recommend you service the filters on this component if applicable. Resample at the next service interval to monitor. We were unable to perform a particle count due to a high concentration of particles present in this sample.
