OIL ANALYSIS REPORT

Machine Id
T-602 (S/N 1-98222-1)
Component
Agitator Gearbox
Fluid
MOBIL MOBILGEAR 630 (7 GAL)

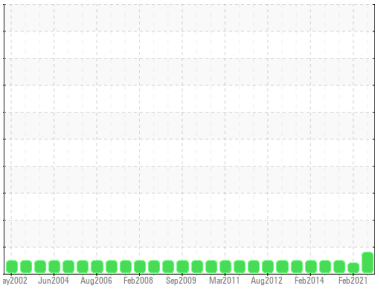
Sample Rating Trend

ABNORMAL	ABNORMAL	NORMAL
Sample Status				**ABNORMAL**	ABNORMAL	NORMAL
Particles >4µm		ASTM D7647	>20000	▲ **61550**	▲ 81668	---
Oil Cleanliness		ISO 4406 (c)	>21/19/16	▲ **23/19/13**	▲ 24/18/13	---

Contamination
There is a high amount of silt (particulates < 14 microns in size) present in the oil.

Resample at the next service interval to monitor.

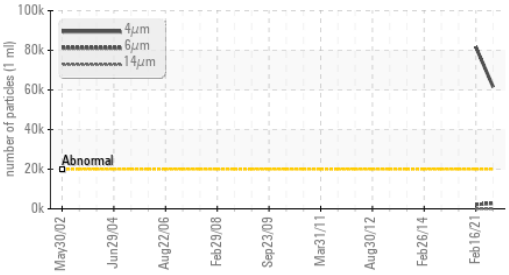
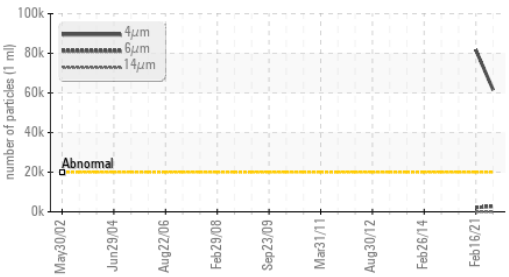
Particle Trend

FLUID CLEANLINESS		method	limit/base	current	history1	history2
Particles >4µm		ASTM D7647	>20000	▲ **61550**	▲ 81668	---
Particles >6µm		ASTM D7647	>5000	**2723**	2167	---
Particles >14µm		ASTM D7647	>640	**67**	61	---
Particles >21µm		ASTM D7647	>160	**16**	13	---
Particles >38µm		ASTM D7647	>40	**2**	0	---
Particles >71µm		ASTM D7647	>10	**1**	0	---
Oil Cleanliness		ISO 4406 (c)	>21/19/16	▲ **23/19/13**	▲ 24/18/13	---

Recommendation
Resample at the next service interval to monitor.
