Customer Id: TAPFRA
Sample No.: RP0021596
Lab Number: 05922276
Test Package: IND 2

OIL ANALYSIS REPORT

Machine Id
LINE 7 SIDE (S/N X56A0100045)
Component
Gearbox
Fluid
SHELL OMALA 320 (--- GAL)

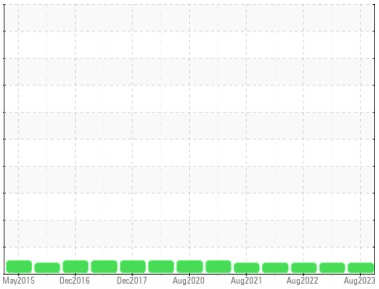
Sample Rating Trend

VIS DEBRIS

Sample Status				**ABNORMAL**	ABNORMAL	ABNORMAL
Debris	scalar	*Visual	NONE	▲ **MODER**	▲ MODER	▲ MODER

No corrective action is recommended at this time.
Resample at the next service interval to monitor.

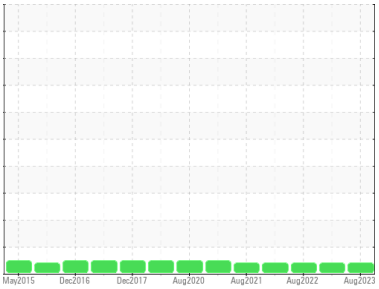
Sample Rating Trend

VIS DEBRIS

Wear
All component wear rates are normal.

Contamination
Moderate concentration of visible dirt/debris present in the oil.

Fluid Condition
The AN level is acceptable for this fluid. The condition of the oil is suitable for further service.

Recommendation
No corrective action is recommended at this time. Resample at the next service interval to monitor.
