Machine Id
LINE 7 MAIN (S/N F02A0100033)
Component
Gearbox
Fluid
SHELL OMALA 320 (35 GAL)

Customer Id: TAPFRA
Sample No.: RP0021595
Lab Number: 05922281
Test Package: IND 2

OIL ANALYSIS REPORT

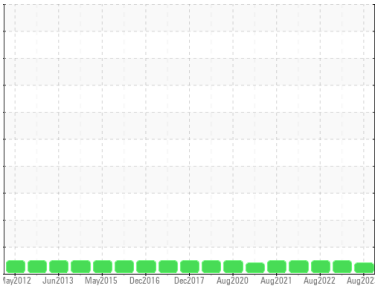
Sample Rating Trend

VISCOSITY

Sample Status				**ATTENTION**	NORMAL	NORMAL
Visc @ 40°C	cSt	ASTM D445	320	▲ **275**	304	307

Confirm the source of the lubricant being utilized for top-up/fill. Resample at the next service interval to monitor.

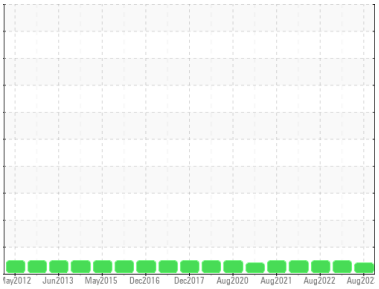
Sample Rating Trend

VISCOSITY

Fluid Condition
The oil viscosity is lower than normal. The AN level is acceptable for this fluid.

Recommendation
Confirm the source of the lubricant being utilized for top-up/fill. Resample at the next service interval to monitor.
