PROBLEM SUMMARY

Machine Id
21
Component
Turbine
Fluid
R&O OIL ISO 68 (--- QTS)

OIL ANALYSIS REPORT

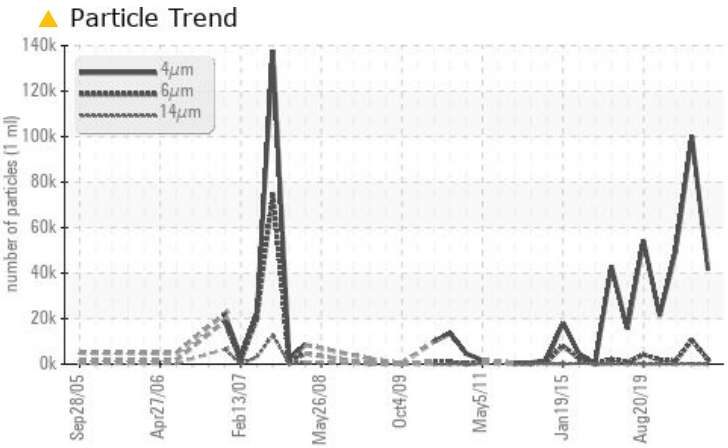
COMPONENT CONDITION SUMMARY

Sample Status				ATTENTION	ABNORMAL	NORMAL
Particles >6µm		ASTM D7647	>1300	▲ **1990**	▲ 10431	1284
Oil Cleanliness		ISO 4406 (c)	>--/17/14	▲ **23/18/12**	▲ 24/21/15	23/17/10

No corrective action is recommended at this time.
Resample at the next service interval to monitor.

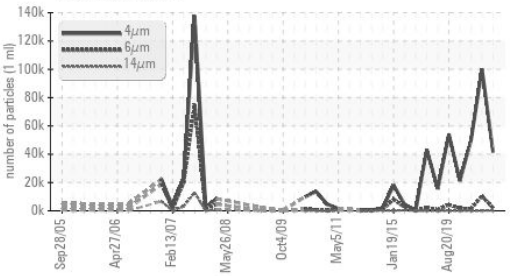
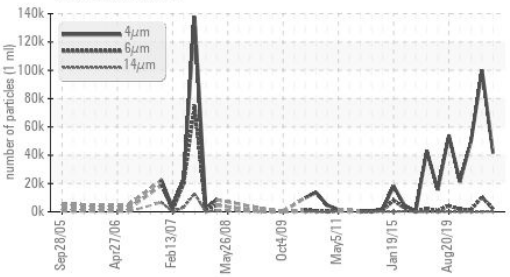
Particle Trend

Contamination
There is a moderate amount of silt (particulates < 14 microns in size) present in the oil.

FLUID CLEANLINESS		method	limit/base	current	history1	history2
Particles >4µm		ASTM D7647		**41466**	100119	49571
Particles >6µm		ASTM D7647	>1300	▲ **1990**	▲ 10431	1284
Particles >14µm		ASTM D7647	>160	**25**	▲ 180	8
Particles >21µm		ASTM D7647	>40	**5**	19	1
Particles >38µm		ASTM D7647	>10	**0**	2	0
Particles >71µm		ASTM D7647	>3	**0**	0	0
Oil Cleanliness		ISO 4406 (c)	>--/17/14	▲ **23/18/12**	▲ 24/21/15	23/17/10

Recommendation
No corrective action is recommended at this time. Resample at the next service interval to monitor.
