Customer Id: NOVFRANC
Sample No.: WC0835756
Lab Number: 05923439
Test Package: IND 2

OIL ANALYSIS REPORT

Area
Recovery
Machine Id
Pro Quip FFI56FB01 Standardization Tank, Agitator
Component
Gearbox
Fluid
JAX MAGNA-PLATE 460 FG (--- GAL)

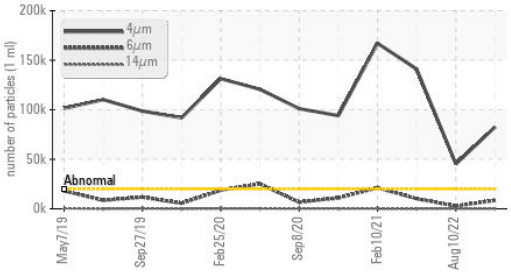
Particle Trend

Sample Status				**ABNORMAL**	ABNORMAL	ABNORMAL
Particles >4µm		ASTM D7647	>20000	▲ **82585**	▲ 45247	▲ 140946
Particles >6µm		ASTM D7647	>5000	▲ **8458**	2735	▲ 10180
Oil Cleanliness		ISO 4406 (c)	>21/19/16	▲ **24/20/13**	▲ 23/19/13	▲ 24/21/13

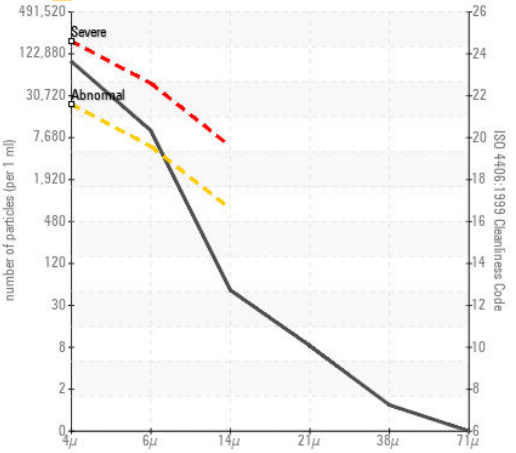
Particle Count

Contamination
There is a high amount of silt (particulates < 14 microns in size) present in the oil.

FLUID CLEANLINESS		method	limit/base	current	history1	history2
Particles >4µm		ASTM D7647	>20000	▲ **82585**	▲ 45247	▲ 140946
Particles >6µm		ASTM D7647	>5000	▲ **8458**	2735	▲ 10180
Particles >14µm		ASTM D7647	>640	**44**	42	60
Particles >21µm		ASTM D7647	>160	**7**	10	8
Particles >38µm		ASTM D7647	>40	**1**	0	1
Particles >71µm		ASTM D7647	>10	**0**	0	0
Oil Cleanliness		ISO 4406 (c)	>21/19/16	▲ **24/20/13**	▲ 23/19/13	▲ 24/21/13

No corrective action is recommended at this time.
Resample at the next service interval to monitor.
