Machine Id
KAESER AIR TOWER 7.5C 8090131 (S/N 1064)
Component
Compressor
Fluid
KAESER SIGMA (OEM) M-460 (--- GAL)

Customer Id: METNAT
Sample No.: KCP55301
Lab Number: 05924288
Test Package: IND 2

OIL ANALYSIS REPORT

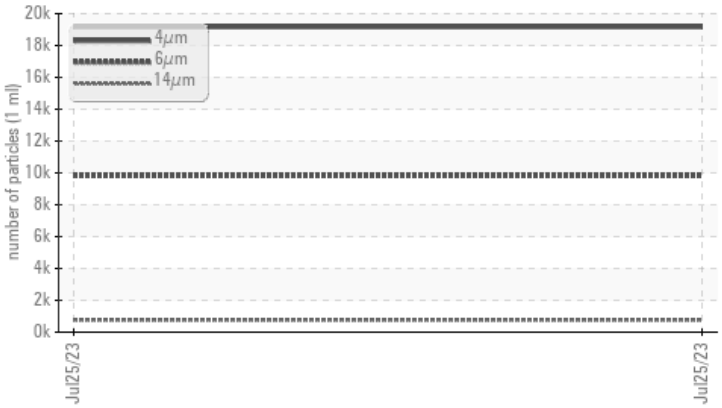
▲ Particle Trend

Sample Status				**ABNORMAL**	---	---
Particles >6µm		ASTM D7647	>1300	▲ **9818**	---	---
Particles >14µm		ASTM D7647	>80	▲ **761**	---	---
Particles >21µm		ASTM D7647	>20	▲ **55**	---	---
Oil Cleanliness		ISO 4406 (c)	>--/17/13	▲ **21/20/17**	---	---

▲ Contamination
There is a high amount of particulates present in the oil.

Oil and filter change at the time of sampling has been noted. No corrective action is recommended at this time. Resample at the next service interval to monitor.

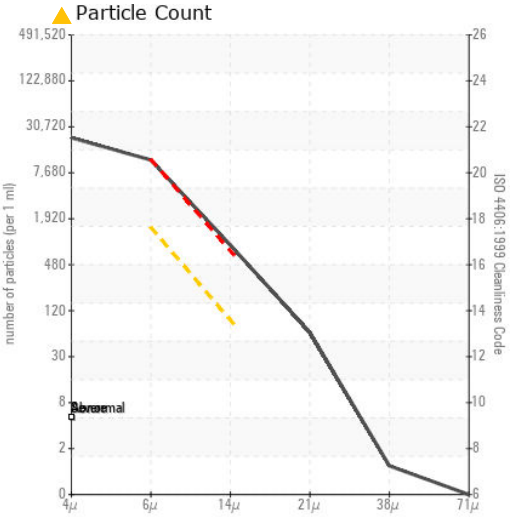
Particle Count

FLUID CLEANLINESS		method	limit/base	current	history1	history2
Particles >4µm		ASTM D7647		**19163**	---	---
Particles >6µm		ASTM D7647	>1300	▲ **9818**	---	---
Particles >14µm		ASTM D7647	>80	▲ **761**	---	---
Particles >21µm		ASTM D7647	>20	▲ **55**	---	---
Particles >38µm		ASTM D7647	>4	**1**	---	---
Particles >71µm		ASTM D7647	>3	**0**	---	---
Oil Cleanliness		ISO 4406 (c)	>--/17/13	▲ **21/20/17**	---	---
