PROBLEM SUMMARY

Machine Id
MHTF_1B MHTF_1B_M1
Component
Non-Drive End Bearing
Fluid
ROYAL PURPLE SYNFILM GT 32 (--- GAL)

Customer Id: ENEAST
Sample No.: RP0027173
Lab Number: 05924412
Test Package: IND 2

OIL ANALYSIS REPORT

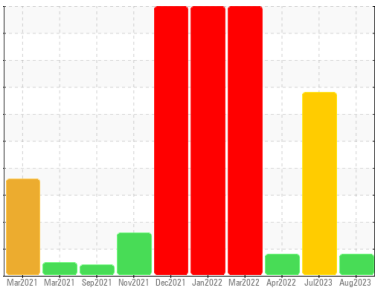
Sample Rating Trend

WEAR

Sample Status				ABNORMAL	SEVERE	ABNORMAL
Lead	ppm	ASTM D5185m	>20	▲ 27	⬢ 91	▲ 26

No corrective action is recommended at this time.
Resample at the next service interval to monitor.

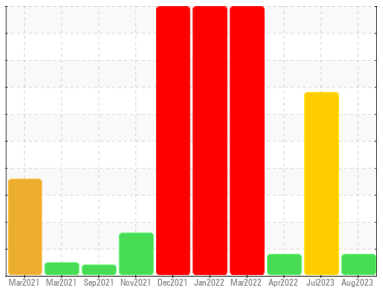
Sample Rating Trend

WEAR

Wear
Bearing wear is indicated.

Contamination
There is no indication of any contamination in the oil.

Fluid Condition
The AN level is acceptable for this fluid. The condition of the oil is suitable for further service.

Recommendation
No corrective action is recommended at this time. Resample at the next service interval to monitor.

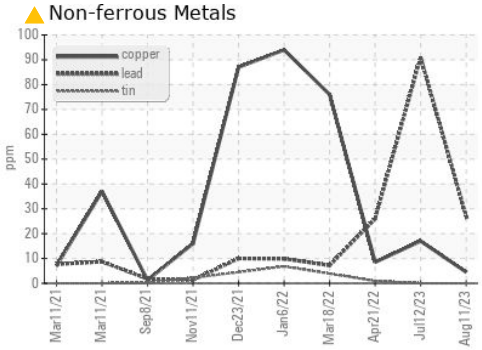
Non-ferrous Metals

WEAR METALS		method	limit/base	current	history1	history2
Iron	ppm	ASTM D5185m	>20	**0**	<1	2
Chromium	ppm	ASTM D5185m	>20	**0**	0	0
Nickel	ppm	ASTM D5185m	>20	**0**	<1	<1
Titanium	ppm	ASTM D5185m		**0**	0	0
Silver	ppm	ASTM D5185m		**0**	0	0
Aluminum	ppm	ASTM D5185m	>20	**<1**	<1	<1
Lead	ppm	ASTM D5185m	>20	▲ **27**	⬢ 91	▲ 26
Copper	ppm	ASTM D5185m	>20	**4**	▲ 17	8
Tin	ppm	ASTM D5185m	>20	**0**	0	<1
Vanadium	ppm	ASTM D5185m		**0**	0	0
Cadmium	ppm	ASTM D5185m		**0**	0	0
