Machine Id
KAESER 8706137 - YENFENG (S/N 2050)
Component
Compressor
Fluid
KAESER SIGMA (OEM) S-460 (--- GAL)

Customer Id: PALFOU
Sample No.: WC0795200
Lab Number: 05925483
Test Package: IND 2

OIL ANALYSIS REPORT

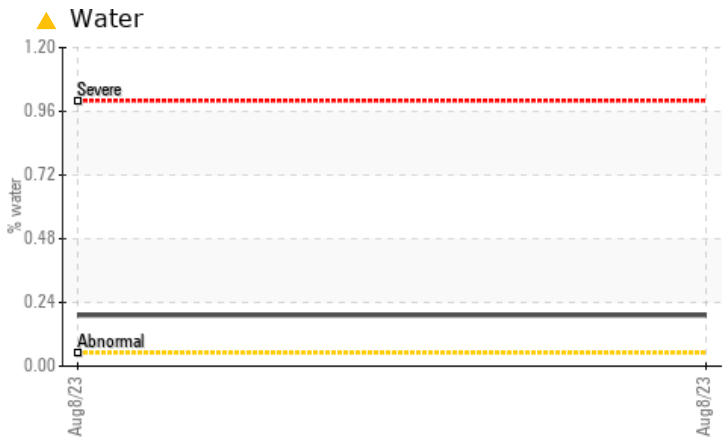
COMPONENT CONDITION SUMMARY

Sample Status				**ABNORMAL**	---	---
Water	%	ASTM D6304	>0.05	▲ **0.192**	---	---
ppm Water	ppm	ASTM D6304	>500	▲ **1920**	---	---
Debris	scalar	*Visual	NONE	▲ **HEAVY**	---	---

High concentration of visible dirt/debris present in the oil. There is a light concentration of water present in the oil.

No corrective action is recommended at this time. The filter change at the time of sampling has been noted. Resample at the next service interval to monitor.
