Area
North Plant-Crystallization
Machine Id
PU-2512C
Component
Hydraulic System
Fluid
ROYAL PURPLE SYNDRAULIC 46 (20 GAL)

Customer Id: AJIEDD
Sample No.: WC0786791
Lab Number: 05926101
Test Package: PLANT

OIL ANALYSIS REPORT

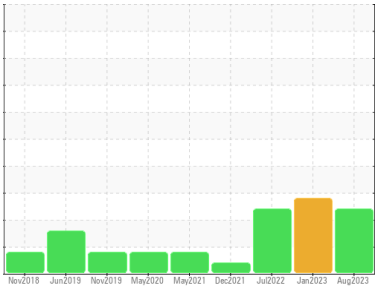
Sample Rating Trend

Sample Status				**ABNORMAL**	ABNORMAL	ABNORMAL
Particles >4µm		ASTM D7647	>640	▲ **4155**	▲ 6349	▲ 3468
Particles >6µm		ASTM D7647	>160	▲ **2441**	▲ 2899	▲ 1344
Particles >14µm		ASTM D7647	>40	▲ **649**	▲ 315	▲ 286
Particles >21µm		ASTM D7647	>10	▲ **250**	▲ 91	▲ 102
Particles >38µm		ASTM D7647	>3	▲ **10**	▲ 10	▲ 7
Oil Cleanliness		ISO 4406 (c)	>16/14/12	▲ **19/18/17**	▲ 20/19/15	▲ 19/18/15

We recommend you service the filters on this component. Resample at the next service interval to monitor.

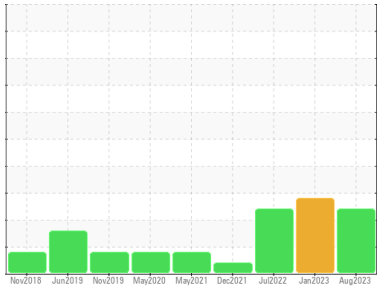
Sample Rating Trend

Contamination
There is a high amount of particulates present in the oil.

FLUID CLEANLINESS		method	limit/base	current	history1	history2
Particles >4µm		ASTM D7647	>640	▲ **4155**	▲ 6349	▲ 3468
Particles >6µm		ASTM D7647	>160	▲ **2441**	▲ 2899	▲ 1344
Particles >14µm		ASTM D7647	>40	▲ **649**	▲ 315	▲ 286
Particles >21µm		ASTM D7647	>10	▲ **250**	▲ 91	▲ 102
Particles >38µm		ASTM D7647	>3	▲ **10**	▲ 10	▲ 7
Particles >71µm		ASTM D7647	>3	**0**	▲ 3	0
Oil Cleanliness		ISO 4406 (c)	>16/14/12	▲ **19/18/17**	▲ 20/19/15	▲ 19/18/15

Recommendation
We recommend you service the filters on this component. Resample at the next service interval to monitor.
