Area
WCLSNC
Machine Id
QC230801HY
Component
Hydraulic System
Fluid
JOHN DEERE HY-GARD HYD/TRANS (--- GAL)

Customer Id: WEACARQA
Sample No.: WC0844493
Lab Number: 05926136
Test Package: IND 2

OIL ANALYSIS REPORT

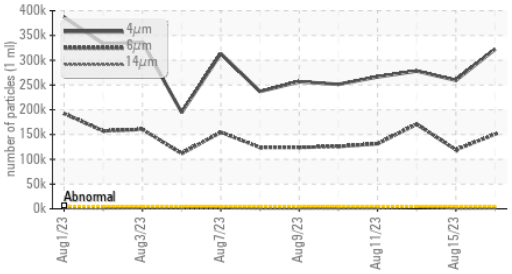
Particle Trend

Contamination
There is a high amount of particulates present in the oil.

FLUID CLEANLINESS		method	limit/base	current	history1	history2
Particles >4µm		ASTM D7647	>5000	▲ **322177**	▲ 259499	▲ 278200
Particles >6µm		ASTM D7647	>1300	▲ **150619**	▲ 119276	▲ 170924
Particles >14µm		ASTM D7647	>160	▲ **1016**	▲ 503	▲ 3561
Particles >21µm		ASTM D7647	>40	**24**	15	▲ 88
Particles >38µm		ASTM D7647	>10	**0**	1	0
Particles >71µm		ASTM D7647	>3	**0**	1	0
Oil Cleanliness		ISO 4406 (c)	>19/17/14	▲ **26/24/17**	▲ 25/24/16	▲ 25/25/19

Recommendation
We recommend you service the filters on this component. Resample at the next service interval to monitor.

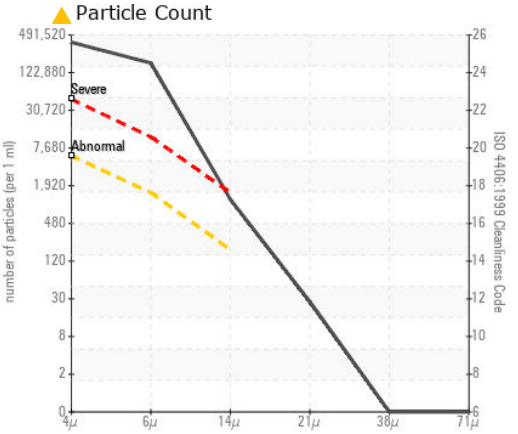
Particle Count

Sample Status				**ABNORMAL**	ABNORMAL	ABNORMAL
Particles >4µm		ASTM D7647	>5000	▲ **322177**	▲ 259499	▲ 278200
Particles >6µm		ASTM D7647	>1300	▲ **150619**	▲ 119276	▲ 170924
Particles >14µm		ASTM D7647	>160	▲ **1016**	▲ 503	▲ 3561
Oil Cleanliness		ISO 4406 (c)	>19/17/14	▲ **26/24/17**	▲ 25/24/16	▲ 25/25/19

We recommend you service the filters on this component. Resample at the next service interval to monitor.
