Machine Id
2400
Component
Diesel Engine
Fluid
CHEVRON DELO 400 SDE SAE 15W40 (--- GAL)

Customer Id: ERGMAG601
Sample No.: WC0829022
Lab Number: 05926614
Test Package: FLEET

OIL ANALYSIS REPORT

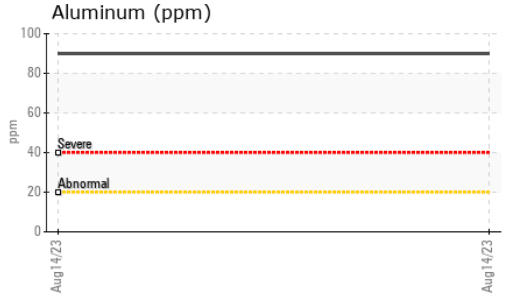
Aluminum (ppm)

Contamination
Elevated aluminum (Al) and/or lead (Pb) and potassium (K) levels in your metals analysis are likely a result of solder flux release into the lubricant and is common on new equipment/components. There is no indication of any contamination in the oil.

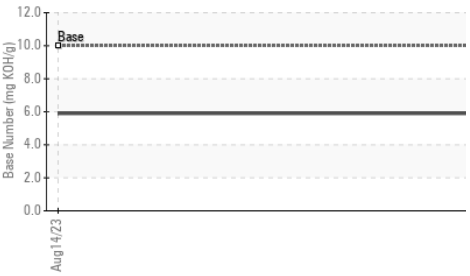
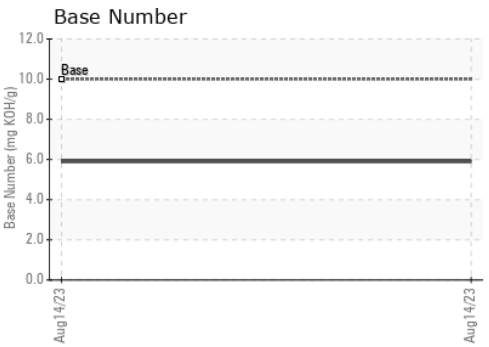
Fluid Condition
The oil viscosity is lower than normal. The BN result indicates that there is suitable alkalinity remaining in the oil. Confirm oil type.

FLUID DEGRADATION		method	limit/base	current	history1	history2
Oxidation	Abs/.1mm	*ASTM D7414	>25	**16.2**	---	---
Base Number (BN)	mg KOH/g	ASTM D2896	10	**5.9**	---	---

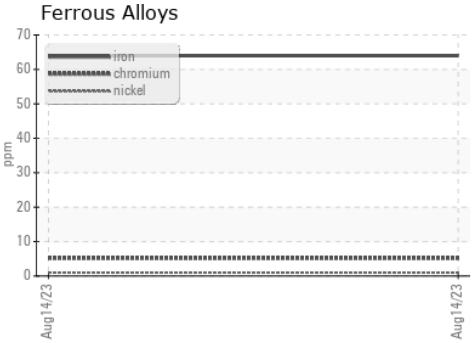
Ferrous Alloys

Wear
Metal levels are typical for a new component breaking in.

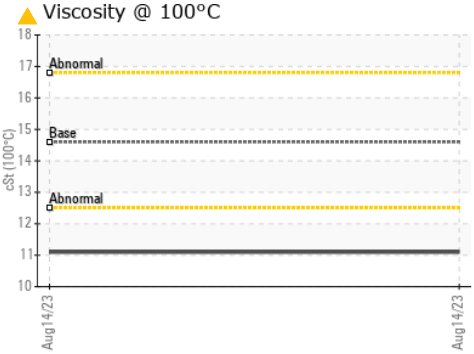
▲ Viscosity @ 100°C

FLUID PROPERTIES		method	limit/base	current	history1	history2
Visc @ 100°C	cSt	ASTM D445	14.6	▲ **11.1**	---	---

Oil and filter change at the time of sampling has been noted. No corrective action is recommended at this time. Resample at the next service interval to monitor.
