Machine Id
KAESER SK20 6533803 (S/N 1171)
Component
Compressor
Fluid
KAESER SIGMA (OEM) S-460 (--- GAL)

Customer Id: AIRHUN
Sample No.: KCPA004123
Lab Number: 05926724
Test Package: IND 2

OIL ANALYSIS REPORT

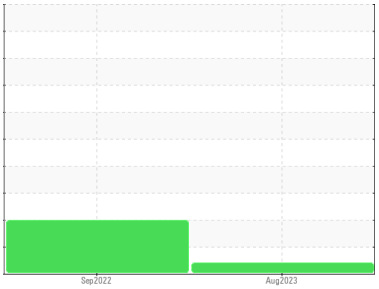
Sample Rating Trend

VIS DEBRIS

Sample Status				**ABNORMAL**	ABNORMAL	---
Debris	scalar	*Visual	NONE	▲ **HEAVY**	LIGHT	---

We recommend you service the filters on this component. Resample at the next service interval to monitor. We were unable to perform a particle count due to a high concentration of particles present in this sample.

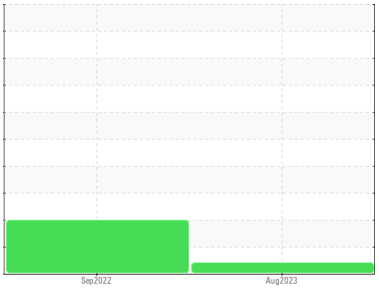
Sample Rating Trend

VIS DEBRIS

Contamination
High concentration of visible dirt/debris present in the oil.

Recommendation
We recommend you service the filters on this component. Resample at the next service interval to monitor. We were unable to perform a particle count due to a high concentration of particles present in this sample.
