OIL ANALYSIS REPORT

Area
37372 (TRACE PO 36471)
Machine Id
JP8TS0001-08142023C
Component
Hydraulic System
Fluid
JP8 MIL-DTL-83133 (--- GAL)

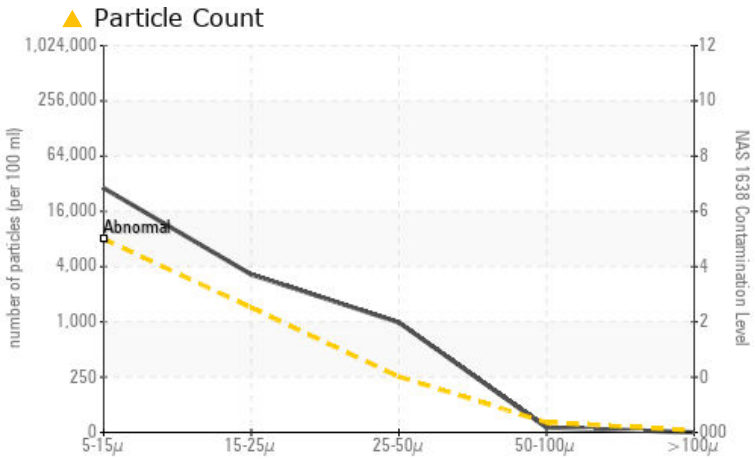
COMPONENT CONDITION SUMMARY

Sample Status				**ABNORMAL**	---	---
Particles 5-15µm	count	*NAS 1638	>8000	▲ **28657**	---	---
Particles 15-25µm	count	*NAS 1638	>1425	▲ **3284**	---	---
Particles 25-50µm	count	*NAS 1638	>253	▲ **987**	---	---

Contamination
There is a high amount of particulates present in the oil. The system cleanliness is above the acceptable limit for the target SAE AS4059 (replaces NAS 1638) cleanliness code.

We advise that you perform a filter service, and use off-line filtration to improve the cleanliness of the system fluid.
