PROBLEM SUMMARY

Area
RP-101
Machine Id
B23353 - PRESS 3
Component
Gearbox
Fluid
MOBIL SHC 636 (--- QTS)

OIL ANALYSIS REPORT

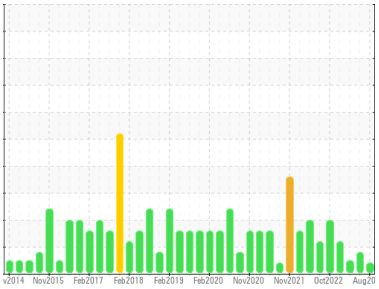
Sample Rating Trend

VIS DEBRIS

Contamination
Moderate concentration of visible dirt/debris present in the oil.

We recommend you service the filters on this component if applicable. Resample at the next service interval to monitor. We were unable to perform a particle count due to a high concentration of particles present in this sample.

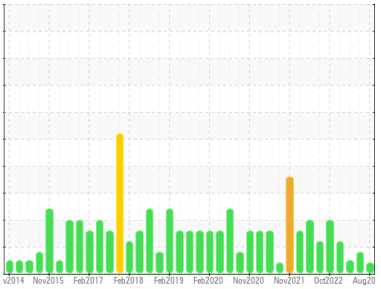
Sample Rating Trend

VIS DEBRIS

Recommendation
We recommend you service the filters on this component if applicable. Resample at the next service interval to monitor. We were unable to perform a particle count due to a high concentration of particles present in this sample.
