Area
Recycled Fiber
Machine Id
Plastic Screw Press #1 Gearbox
Component
Gearbox
Fluid
MOBIL MOBILGEAR SHC 320 (--- GAL)

OIL ANALYSIS REPORT

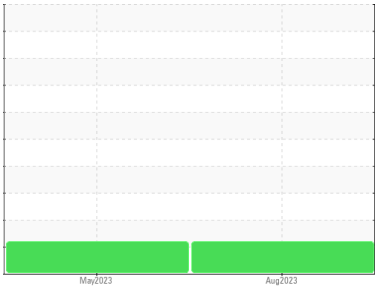
Sample Rating Trend

Sample Status				**ABNORMAL**	ABNORMAL	---
Particles >4µm		ASTM D7647	>20000	▲ **75152**	▲ 52826	---
Particles >6µm		ASTM D7647	>5000	▲ **10405**	▲ 9787	---
Oil Cleanliness		ISO 4406 (c)	>21/19/16	▲ **23/21/12**	▲ 23/20/14	---

No corrective action is recommended at this time.
Resample at the next service interval to monitor.

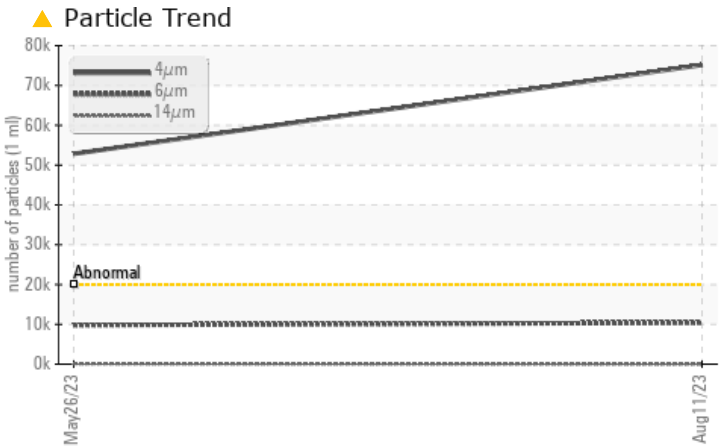
COMPONENT CONDITION SUMMARY

There is a high amount of silt (particulates < 14 microns in size) present in the oil.

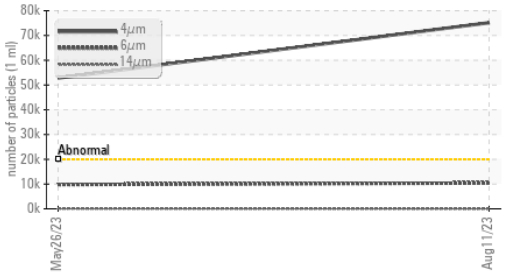
Particle Trend

FLUID CLEANLINESS		method	limit/base	current	history1	history2
Particles >4µm		ASTM D7647	>20000	▲ **75152**	▲ 52826	---
Particles >6µm		ASTM D7647	>5000	▲ **10405**	▲ 9787	---
Particles >14µm		ASTM D7647	>640	**38**	114	---
Particles >21µm		ASTM D7647	>160	**5**	13	---
Particles >38µm		ASTM D7647	>40	**0**	1	---
Particles >71µm		ASTM D7647	>10	**0**	1	---
Oil Cleanliness		ISO 4406 (c)	>21/19/16	▲ **23/21/12**	▲ 23/20/14	---

No corrective action is recommended at this time. Resample at the next service interval to monitor.
