Customer Id: CASASH
Sample No.: WC0776605
Lab Number: 05927247
Test Package: PLANT

OIL ANALYSIS REPORT

Area
Paper Machine
Machine Id
Pick-up Roll Suction Gearbox
Component
Gearbox
Fluid
MOBIL MOBILGEAR SHC 320 (--- GAL)

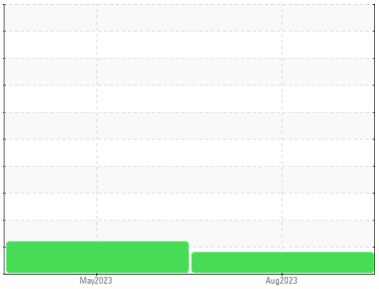
Sample Rating Trend

Contamination
There is a high amount of silt (particulates < 14 microns in size) present in the oil.

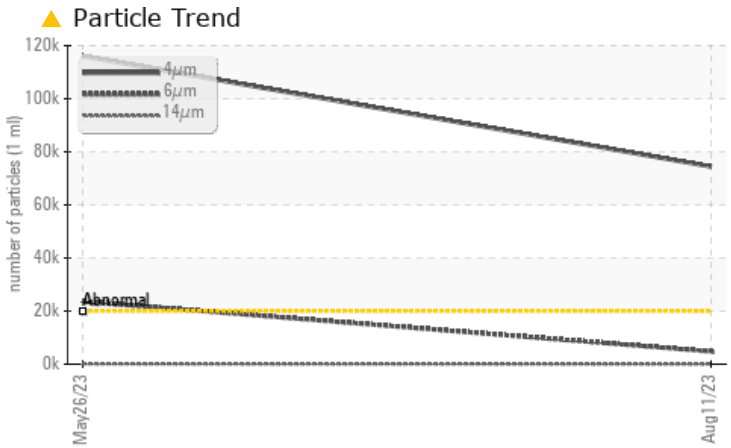
COMPONENT CONDITION SUMMARY

Sample Status				**ABNORMAL**	ABNORMAL	---
Particles >4µm		ASTM D7647	>20000	▲ **74428**	▲ 116068	---
Oil Cleanliness		ISO 4406 (c)	>21/19/16	▲ **23/19/12**	▲ 24/22/14	---

No corrective action is recommended at this time.
Resample at the next service interval to monitor.

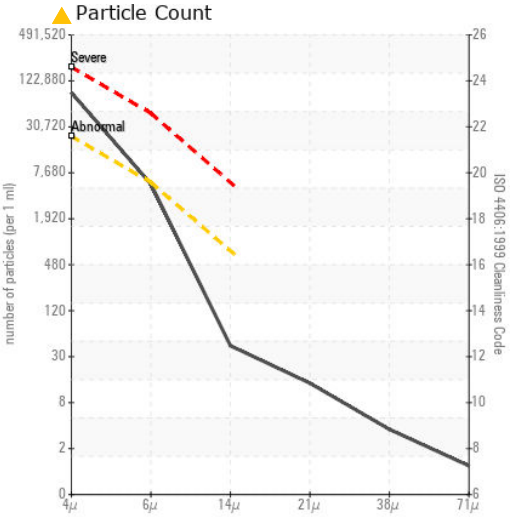
Particle Count

FLUID CLEANLINESS		method	limit/base	current	history1	history2
Particles >4µm		ASTM D7647	>20000	▲ **74428**	▲ 116068	---
Particles >6µm		ASTM D7647	>5000	**4766**	▲ 23583	---
Particles >14µm		ASTM D7647	>640	**37**	104	---
Particles >21µm		ASTM D7647	>160	**12**	8	---
Particles >38µm		ASTM D7647	>40	**3**	1	---
Particles >71µm		ASTM D7647	>10	**1**	0	---
Oil Cleanliness		ISO 4406 (c)	>21/19/16	▲ **23/19/12**	▲ 24/22/14	---

Recommendation
No corrective action is recommended at this time. Resample at the next service interval to monitor.
