Area
Paper Machine
Machine Id
Wet End Lubrication System
Component
Bearing Lube
Fluid
MOBIL DTE PM 220 (2000 GAL)

Customer Id: CASASH
Sample No.: WC0776556
Lab Number: 05927249
Test Package: PLANT

OIL ANALYSIS REPORT

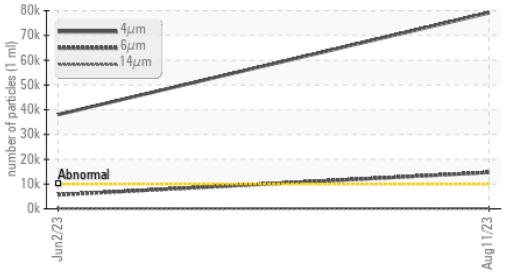
Particle Trend

Contamination
There is a high amount of silt (particulates < 14 microns in size) present in the oil.

FLUID CLEANLINESS		method	limit/base	current	history1	history2
Particles >4µm		ASTM D7647	>10000	▲ **79149**	▲ 38034	---
Particles >6µm		ASTM D7647	>2500	▲ **14713**	▲ 5654	---
Particles >14µm		ASTM D7647	>160	**148**	54	---
Particles >21µm		ASTM D7647	>40	**18**	5	---
Particles >38µm		ASTM D7647	>10	**1**	0	---
Particles >71µm		ASTM D7647	>3	**0**	0	---
Oil Cleanliness		ISO 4406 (c)	>20/18/14	▲ **23/21/14**	▲ 22/20/13	---

No corrective action is recommended at this time.
Resample at the next service interval to monitor.
