Area
Effluent Treatment Plant
Machine Id
Sludge Screw Press #1 Gearbox
Component
Gearbox
Fluid
MOBIL MOBILGEAR SHC 320 (225 GAL)

Customer Id: CASASH
Sample No.: WC0776603
Lab Number: 05927256
Test Package: PLANT

OIL ANALYSIS REPORT

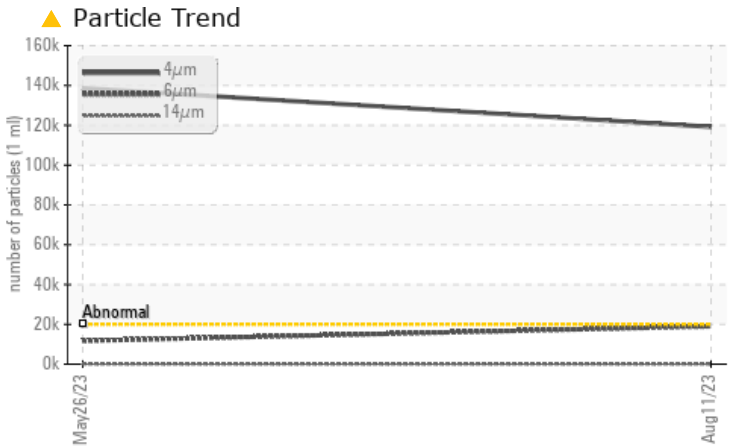
COMPONENT CONDITION SUMMARY

Sample Status				**ABNORMAL**	ABNORMAL	---
Particles >4µm		ASTM D7647	>20000	▲ **119204**	▲ 138648	---
Particles >6µm		ASTM D7647	>5000	▲ **18998**	▲ 11728	---
Oil Cleanliness		ISO 4406 (c)	>21/19/16	▲ **24/21/14**	▲ 24/21/14	---

There is a high amount of silt (particulates < 14 microns in size) present in the oil.

No corrective action is recommended at this time.
Resample at the next service interval to monitor.

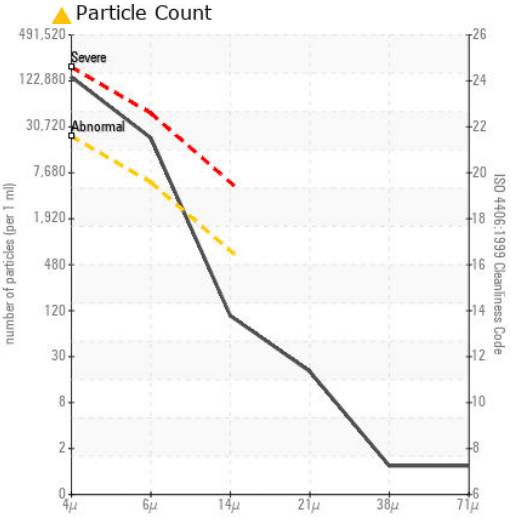
Particle Count

FLUID CLEANLINESS		method	limit/base	current	history1	history2
Particles >4µm		ASTM D7647	>20000	▲ **119204**	▲ 138648	---
Particles >6µm		ASTM D7647	>5000	▲ **18998**	▲ 11728	---
Particles >14µm		ASTM D7647	>640	**91**	94	---
Particles >21µm		ASTM D7647	>160	**17**	14	---
Particles >38µm		ASTM D7647	>40	**1**	1	---
Particles >71µm		ASTM D7647	>10	**1**	0	---
Oil Cleanliness		ISO 4406 (c)	>21/19/16	▲ **24/21/14**	▲ 24/21/14	---

No corrective action is recommended at this time. Resample at the next service interval to monitor.
