Customer Id: CASASH
Sample No.: WC0776602
Lab Number: 05927257
Test Package: PLANT

OIL ANALYSIS REPORT

Area
Effluent Treatment Plant
Machine Id
Sludge Screw Press #2 Gearbox
Component
Gearbox
Fluid
MOBIL MOBILGEAR SHC 320 (225 GAL)

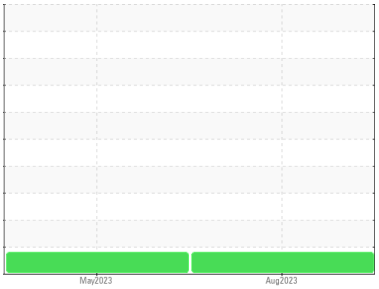
Sample Rating Trend

Sample Status				**ABNORMAL**	ABNORMAL	---
Particles >4µm		ASTM D7647	>20000	▲ **71448**	▲ 62002	---
Oil Cleanliness		ISO 4406 (c)	>21/19/16	▲ **23/19/13**	▲ 23/19/13	---

There is a high amount of silt (particulates < 6 microns in size) present in the oil.

No corrective action is recommended at this time.
Resample at the next service interval to monitor.

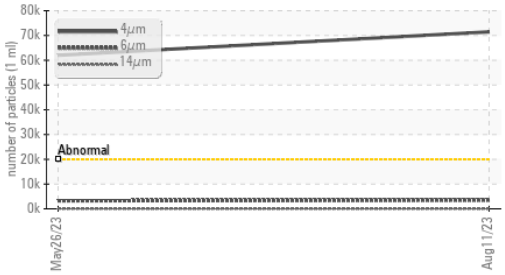
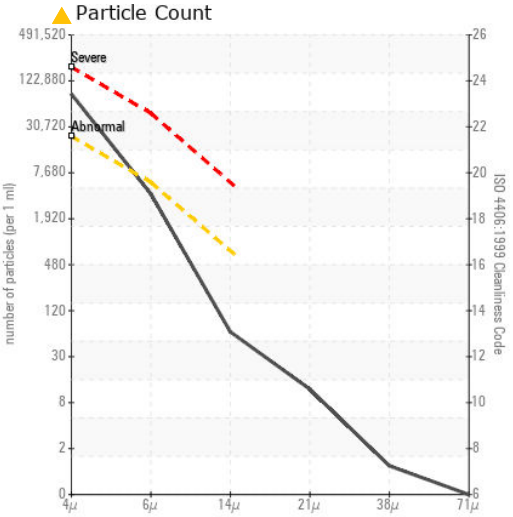
Particle Trend

FLUID CLEANLINESS		method	limit/base	current	history1	history2
Particles >4µm		ASTM D7647	>20000	▲ **71448**	▲ 62002	---
Particles >6µm		ASTM D7647	>5000	**3538**	3245	---
Particles >14µm		ASTM D7647	>640	**56**	61	---
Particles >21µm		ASTM D7647	>160	**10**	9	---
Particles >38µm		ASTM D7647	>40	**1**	1	---
Particles >71µm		ASTM D7647	>10	**0**	1	---
Oil Cleanliness		ISO 4406 (c)	>21/19/16	▲ **23/19/13**	▲ 23/19/13	---

No corrective action is recommended at this time. Resample at the next service interval to monitor.

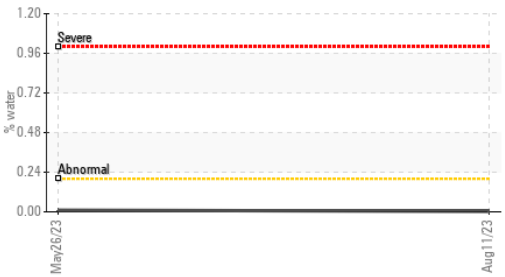
CONTAMINANTS		method	limit/base	current	history1	history2
Silicon	ppm	ASTM D5185m	>50	**20**	21	---
Sodium	ppm	ASTM D5185m		**<1**	0	---
Potassium	ppm	ASTM D5185m	>20	**2**	<1	---
Water	%	ASTM D6304	>0.2	**0.003**	0.010	---
ppm Water	ppm	ASTM D6304	>2000	**35.3**	103.8	---

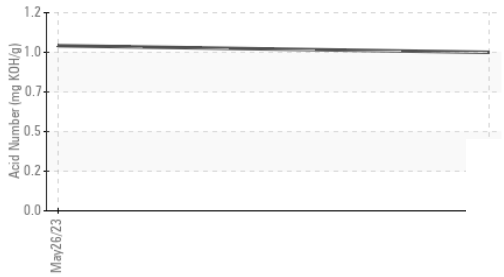
Acid Number

The AN level is acceptable for this fluid. The condition of the oil is suitable for further service.

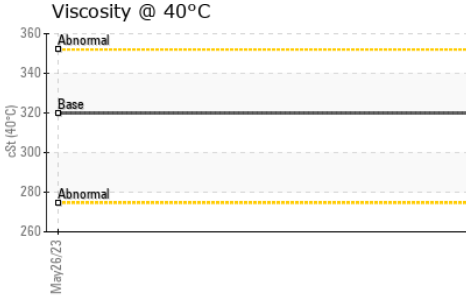
Viscosity @ 40°C

FLUID PROPERTIES		method	limit/base	current	history1	history2
Visc @ 40°C	cSt	ASTM D445	320	**320**	320	---

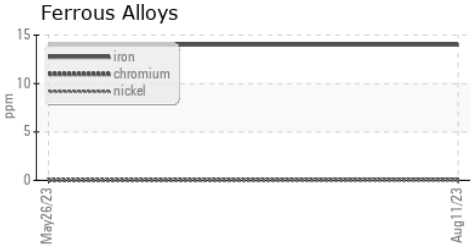
Ferrous Alloys

All component wear rates are normal.
