Machine Id
RC-7 PO (S/N 4513 A RC)
Component
Refrigeration Compressor
Fluid
USPI 1009-68 SC (--- GAL)

Customer Id: KRAKEN
Sample No.: USP0000637
Lab Number: 05927310
Test Package: IND 2

OIL ANALYSIS REPORT

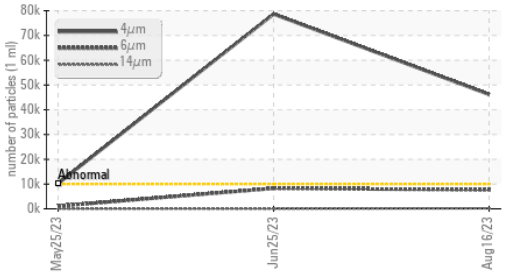
Particle Trend

Contamination
There is a high amount of silt (particulates < 14 microns in size) present in the oil.

FLUID CLEANLINESS		method	limit/base	current	history1	history2
Particles >4µm		ASTM D7647	>10000	▲ **46162**	▲ 78642	▲ 10230
Particles >6µm		ASTM D7647	>2500	▲ **7661**	▲ 8276	1108
Particles >14µm		ASTM D7647	>640	**188**	27	30
Particles >21µm		ASTM D7647	>160	**23**	3	5
Particles >38µm		ASTM D7647	>40	**1**	0	1
Particles >71µm		ASTM D7647	>10	**0**	0	0
Oil Cleanliness		ISO 4406 (c)	>20/18/16	▲ **23/20/15**	▲ 23/20/12	▲ 21/17/12

Recommendation
Resample at the next service interval to monitor.
