PROBLEM SUMMARY

Area
HIGHLAND [600380484]
Machine Id
06WEA80813
Component
Hydraulic System
Fluid
SHELL TELLUS ARTIC 32 (--- LTR)

OIL ANALYSIS REPORT

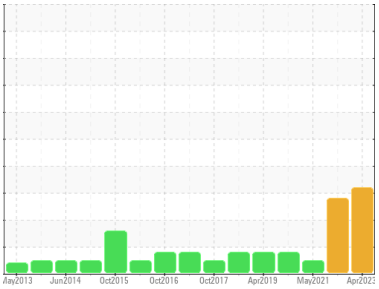
Sample Rating Trend

WATER

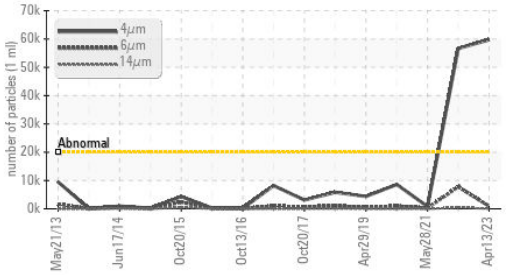
Particle Trend

FLUID CLEANLINESS		method	limit/base	current	history1	history2
Particles >4µm		ASTM D7647	>20000	▲ **59740**	▲ 56662	811
Particles >6µm		ASTM D7647	>2500	**934**	▲ 7790	239
Particles >14µm		ASTM D7647	>320	**37**	▲ 429	20
Particles >21µm		ASTM D7647	>80	**9**	▲ 116	1
Particles >38µm		ASTM D7647	>20	**0**	5	0
Particles >71µm		ASTM D7647	>4	**0**	0	0
Oil Cleanliness		ISO 4406 (c)	>21/18/15	▲ **23/17/12**	▲ 23/20/16	17/15/11

We recommend you service the filters on this component. Resample at the next service interval to monitor.

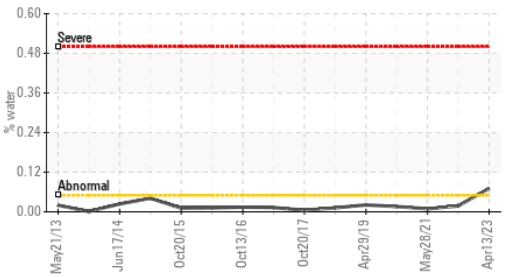
CONTAMINANTS		method	limit/base	current	history1	history2
Silicon	ppm	ASTM D5185m	>15	**1**	5	2
Sodium	ppm	ASTM D5185m		**0**	1	<1
Potassium	ppm	ASTM D5185m	>20	**<1**	0	0
Water	%	ASTM D6304	>0.05	▲ **0.071**	0.018	0.009
ppm Water	ppm	ASTM D6304	>500	▲ **710**	189.3	97.3

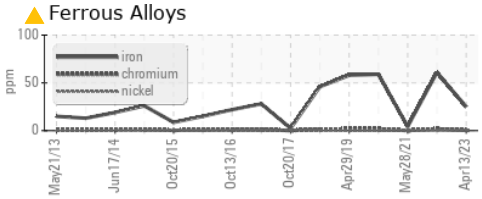
Ferrous Alloys

Wear
The iron level is abnormal. All other component wear rates are normal.

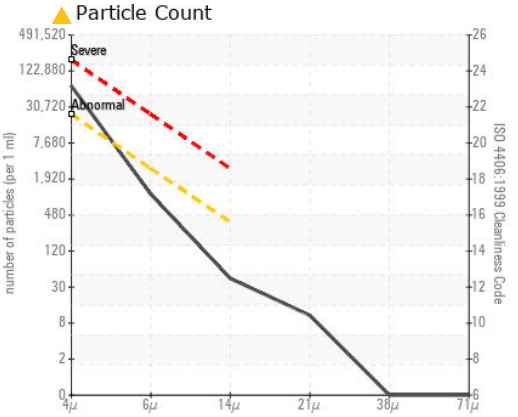
Particle Count

Contamination
There is a high amount of silt (particulates < 14 microns in size) present in the oil. There is a light concentration of water present in the oil.
