# PROBLEM SUMMARY

Area
**HIGHLAND [600380371]**
Machine Id
**05WEA80812**
Component
**Hydraulic System**
Fluid
**SHELL TELLUS ARTIC 32 (--- LTR)**

# OIL ANALYSIS REPORT

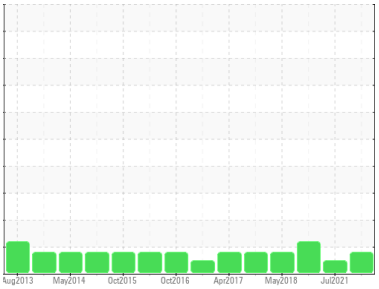
Sample Rating Trend

| Sample Status | | | | ATTENTION | NORMAL | ABNORMAL |
|---|---|---|---|---|---|---|
| Particles >6µm | | ASTM D7647 | >2500 | ▲ **2518** | 539 | ▲ 3017 |
| Oil Cleanliness | | ISO 4406 (c) | >21/18/15 | ▲ **21/19/14** | 20/16/12 | ▲ 21/19/14 |

No corrective action is recommended at this time.
Resample at the next service interval to monitor.

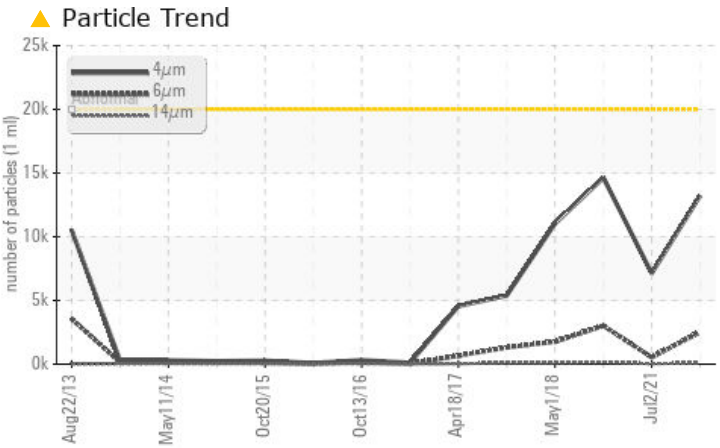
## COMPONENT CONDITION SUMMARY

**Wear**
All component wear rates are normal.

**Contamination**
There is a moderate amount of silt (particulates < 14 microns in size) present in the oil.

**Fluid Condition**
The AN level is acceptable for this fluid. The condition of the oil is suitable for further service.
