Area
HIGHLAND [600380502]
Machine Id
24WEA80816
Component
Hydraulic System
Fluid
SHELL TELLUS ARTIC 32 (--- LTR)

Customer Id: NORHIG
Sample No.: NX05928178
Lab Number: 05928178
Test Package: IND 2

OIL ANALYSIS REPORT

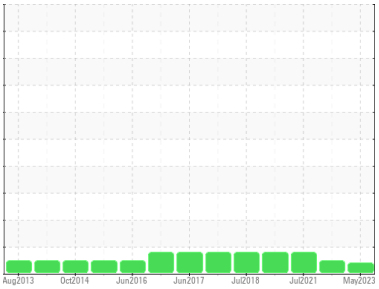
Sample Rating Trend

VIS DEBRIS

Sample Status				**ABNORMAL**	NORMAL	MARGINAL
Debris	scalar	*Visual	NONE	▲ **MODER**	NONE	NONE

Contamination
Moderate concentration of visible dirt/debris present in the oil.

We recommend you service the filters on this component. Resample at the next service interval to monitor. We were unable to perform a particle count due to a high concentration of particles present in this sample.

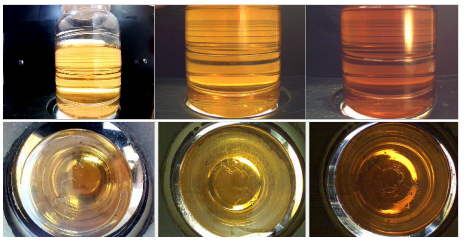
SAMPLE IMAGES	method	limit/base	current	history1	history2
Color					
Bottom

VISUAL		method	limit/base	current	history1	history2
White Metal	scalar	*Visual	NONE	**NONE**	NONE	NONE
Yellow Metal	scalar	*Visual	NONE	**NONE**	NONE	NONE
Precipitate	scalar	*Visual	NONE	**NONE**	NONE	NONE
Silt	scalar	*Visual	NONE	**NONE**	NONE	NONE
Debris	scalar	*Visual	NONE	▲ **MODER**	NONE	NONE
Sand/Dirt	scalar	*Visual	NONE	**NONE**	NONE	NONE
Appearance	scalar	*Visual	NORML	**NORML**	NORML	NORML
Odor	scalar	*Visual	NORML	**NORML**	NORML	NORML
Emulsified Water	scalar	*Visual	>0.05	**NEG**	NEG	NEG
Free Water	scalar	*Visual		**NEG**	NEG	NEG

Recommendation
We recommend you service the filters on this component. Resample at the next service interval to monitor. We were unable to perform a particle count due to a high concentration of particles present in this sample.
