# PROBLEM SUMMARY

Area
**HIGHLAND [600380490]**
Machine Id
**12WEA80819**
Component
**Hydraulic System**
Fluid
**SHELL TELLUS ARTIC 32 (--- LTR)**

# OIL ANALYSIS REPORT

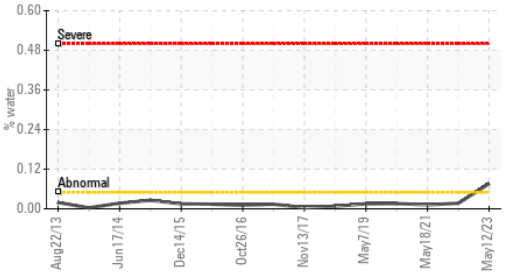
Water

**Contamination**
There is a light concentration of water present in the oil. The amount and size of particulates present in the system are acceptable.

**Recommendation**
Resample at the next service interval to monitor.
