PROBLEM SUMMARY

Area
HIGHLAND [600380489]
Machine Id
11WEA80818
Component
Hydraulic System
Fluid
SHELL TELLUS ARTIC 32 (--- LTR)

OIL ANALYSIS REPORT

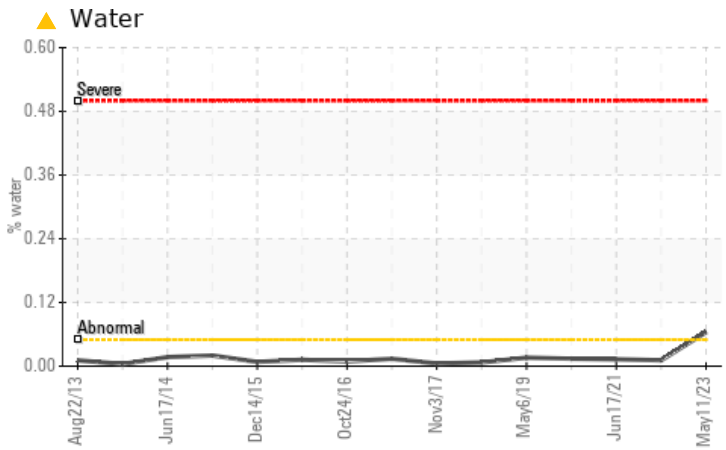
COMPONENT CONDITION SUMMARY

Sample Status				MARGINAL	NORMAL	ABNORMAL
Water	%	ASTM D6304	>0.05	▲ **0.064**	0.011	0.013
ppm Water	ppm	ASTM D6304	>500	▲ **640**	119.2	137.5

Contamination
There is a light concentration of water present in the oil. The amount and size of particulates present in the system are acceptable.

Resample at the next service interval to monitor.

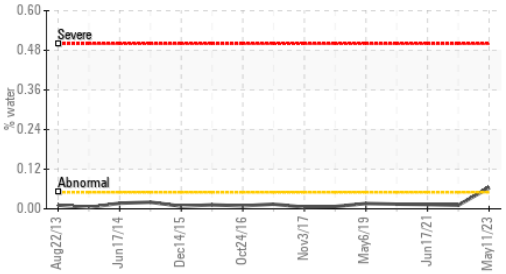
CONTAMINANTS		method	limit/base	current	history1	history2
Silicon	ppm	ASTM D5185m	>15	**1**	<1	2
Sodium	ppm	ASTM D5185m		**0**	0	<1
Potassium	ppm	ASTM D5185m	>20	**<1**	0	<1
Water	%	ASTM D6304	>0.05	▲ **0.064**	0.011	0.013
ppm Water	ppm	ASTM D6304	>500	▲ **640**	119.2	137.5

Recommendation
Resample at the next service interval to monitor.

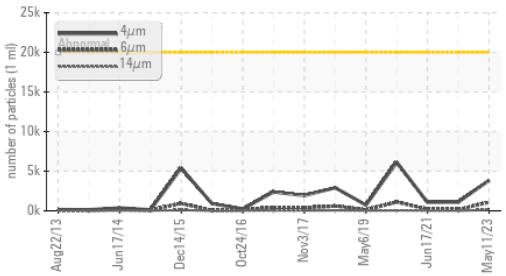
Particle Trend

FLUID CLEANLINESS		method	limit/base	current	history1	history2
Particles >4µm		ASTM D7647	>20000	**3843**	1095	1077
Particles >6µm		ASTM D7647	>2500	**1068**	156	206
Particles >14µm		ASTM D7647	>320	**118**	10	14
Particles >21µm		ASTM D7647	>80	**39**	4	3
Particles >38µm		ASTM D7647	>20	**4**	0	0
Particles >71µm		ASTM D7647	>4	**0**	0	0
Oil Cleanliness		ISO 4406 (c)	>21/18/15	**19/17/14**	17/14/10	17/15/11

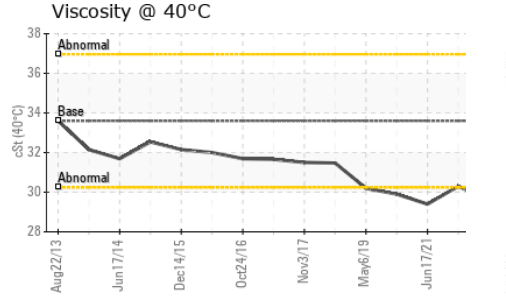
Viscosity @ 40°C

FLUID PROPERTIES		method	limit/base	current	history1	history2
Visc @ 40°C	cSt	ASTM D445	33.6	**29.6**	30.3	29.4

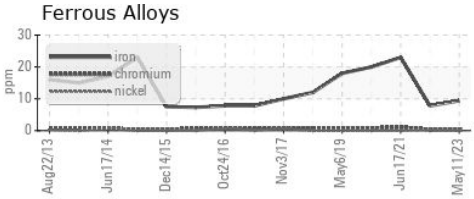
Ferrous Alloys

WEAR METALS		method	limit/base	current	history1	history2
PQ		ASTM D8184		**12**	16	17
Iron	ppm	ASTM D5185m	>20	**9**	8	▲ 23
Chromium	ppm	ASTM D5185m	>20	**<1**	<1	1
Nickel	ppm	ASTM D5185m	>20	**0**	<1	0
Titanium	ppm	ASTM D5185m		**0**	0	0
Silver	ppm	ASTM D5185m		**0**	<1	<1
Aluminum	ppm	ASTM D5185m	>20	**0**	0	<1
Lead	ppm	ASTM D5185m	>20	**2**	2	6
Copper	ppm	ASTM D5185m	>20	**<1**	<1	<1
Tin	ppm	ASTM D5185m	>20	**0**	<1	<1
Antimony	ppm	ASTM D5185m		**---**	---	0
Vanadium	ppm	ASTM D5185m		**0**	0	0
Cadmium	ppm	ASTM D5185m		**0**	0	0

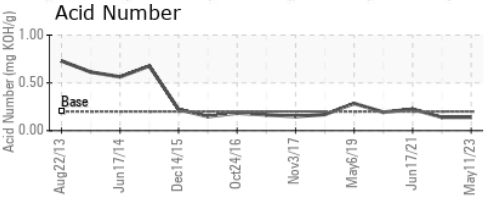
FLUID DEGRADATION		method	limit/base	current	history1	history2
Acid Number (AN)	mg KOH/g	ASTM D8045	0.20	**0.14**	0.14	0.225
