Area
HIGHLAND [600380498]
Machine Id
20WEA80827
Component
Wind Turbine Gearbox
Fluid
MOBIL XMP 320 (--- LTR)

Customer Id: NORHIG
Sample No.: NX05928196
Lab Number: 05928196
Test Package: IND 2

OIL ANALYSIS REPORT

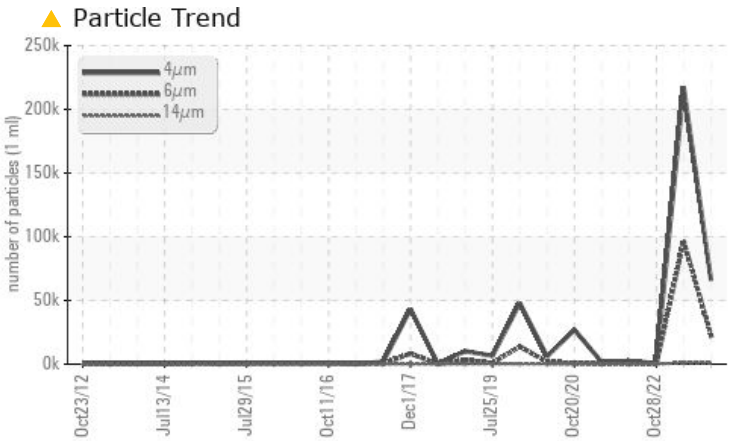
COMPONENT CONDITION SUMMARY

Sample Status				**ABNORMAL**	ABNORMAL	NORMAL
Particles >6µm		ASTM D7647	>2500	▲ **23019**	▲ 96721	83
Particles >14µm		ASTM D7647	>320	▲ **817**	▲ 1052	6
Oil Cleanliness		ISO 4406 (c)	>--/18/15	▲ **23/22/17**	▲ 25/24/17	17/14/10

Contamination
There is a high amount of particulates present in the oil.

We recommend you service the filters on this component. Resample at the next service interval to monitor.
