PROBLEM SUMMARY

Area
HIGHLAND [600380497]
Machine Id
19WEA80826
Component
Wind Turbine Gearbox
Fluid
MOBIL XMP 320 (--- LTR)

OIL ANALYSIS REPORT

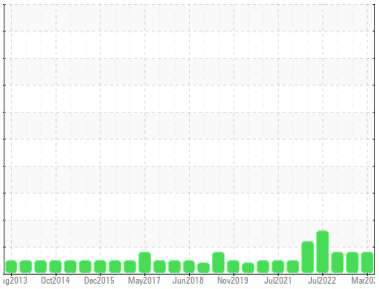
Sample Rating Trend

Sample Status				**ABNORMAL**	ABNORMAL	ABNORMAL
Particles >6µm		ASTM D7647	>2500	▲ **11980**	▲ 6546	▲ 12835
Oil Cleanliness		ISO 4406 (c)	>--/18/15	▲ **23/21/12**	▲ 23/20/15	▲ 23/21/14

We recommend you service the filters on this component if applicable. Resample at the next service interval to monitor.

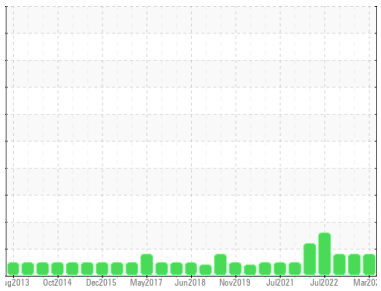
Sample Rating Trend

Contamination
There is a high amount of silt (particulates < 14 microns in size) present in the oil.

FLUID CLEANLINESS		method	limit/base	current	history1	history2
Particles >4µm		ASTM D7647		**68295**	45432	77361
Particles >6µm		ASTM D7647	>2500	▲ **11980**	▲ 6546	▲ 12835
Particles >14µm		ASTM D7647	>320	**27**	185	145
Particles >21µm		ASTM D7647	>80	**5**	40	20
Particles >38µm		ASTM D7647	>20	**0**	2	0
Particles >71µm		ASTM D7647	>4	**0**	0	0
Oil Cleanliness		ISO 4406 (c)	>--/18/15	▲ **23/21/12**	▲ 23/20/15	▲ 23/21/14

Recommendation
We recommend you service the filters on this component if applicable. Resample at the next service interval to monitor.
