Customer Id: NORHIG
Sample No.: NX05928204
Lab Number: 05928204
Test Package: IND 2

OIL ANALYSIS REPORT

Area
HIGHLAND [600380494]
Machine Id
16WEA80823
Component
Wind Turbine Gearbox
Fluid
MOBIL XMP 320 (--- LTR)

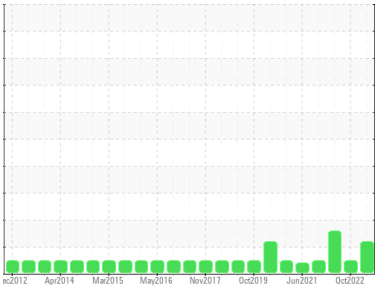
VISUAL METAL

Sample Status				**ABNORMAL**	NORMAL	ABNORMAL
White Metal	scalar	*Visual	NONE	▲ **MODER**	NONE	LIGHT

Moderate concentration of visible metal present. All component wear rates are normal.

We recommend you service the filters on this component if applicable. Resample at the next service interval to monitor. We were unable to perform a particle count due to metal particles present in this sample.

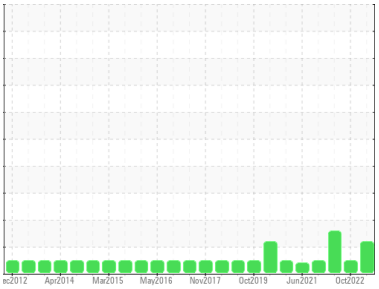
VISUAL METAL

We recommend you service the filters on this component if applicable. Resample at the next service interval to monitor. We were unable to perform a particle count due to metal particles present in this sample.
