PROBLEM SUMMARY

Area
HIGHLAND [600380484]
Machine Id
06WEA80813
Component
Wind Turbine Gearbox
Fluid
MOBIL XMP 320 (--- LTR)

OIL ANALYSIS REPORT

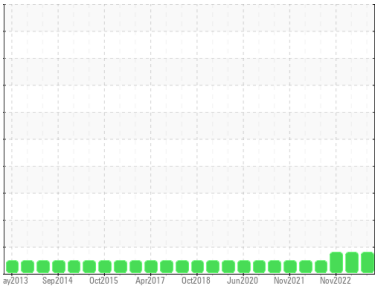
Sample Rating Trend

▲ Particle Trend

Sample Status				**ATTENTION**	ATTENTION	ATTENTION
Particles >6µm		ASTM D7647	>2500	▲ **2865**	▲ 3840	▲ 3671
Oil Cleanliness		ISO 4406 (c)	>--/18/15	▲ **21/19/14**	▲ 21/19/14	▲ 22/19/11

Contamination
There is a moderate amount of silt (particulates < 14 microns in size) present in the oil.

No corrective action is recommended at this time.
Resample at the next service interval to monitor.

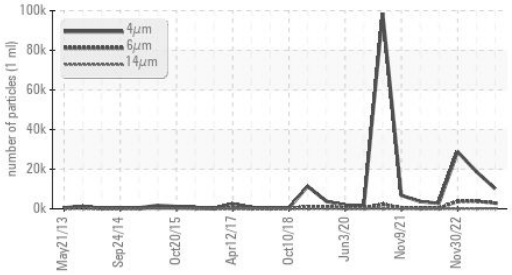
Particle Trend

FLUID CLEANLINESS		method	limit/base	current	history1	history2
Particles >4µm		ASTM D7647		**10171**	18791	28774
Particles >6µm		ASTM D7647	>2500	▲ **2865**	▲ 3840	▲ 3671
Particles >14µm		ASTM D7647	>320	**132**	138	20
Particles >21µm		ASTM D7647	>80	**24**	24	2
Particles >38µm		ASTM D7647	>20	**1**	2	1
Particles >71µm		ASTM D7647	>4	**0**	0	0
Oil Cleanliness		ISO 4406 (c)	>--/18/15	▲ **21/19/14**	▲ 21/19/14	▲ 22/19/11
