Customer Id: IBPDAK01
Sample No.: USPM29250
Lab Number: 05928333
Test Package: IND 2

OIL ANALYSIS REPORT

Machine Id
TYSDAKPRO HYD 2 BRISKET CLIPPER (S/N X0337XFMNTHAC03)
Component
Hydraulic System
Fluid
USPI FG HYD 46 (--- GAL)

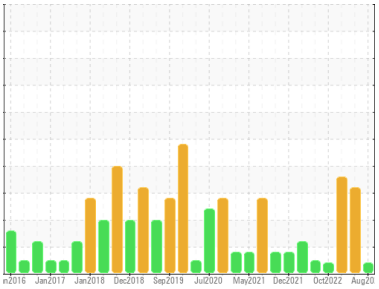
Sample Rating Trend

VIS DEBRIS

We recommend you service the filters on this component. Resample at the next service interval to monitor. We were unable to perform a particle count due to a high concentration of particles present in this sample.

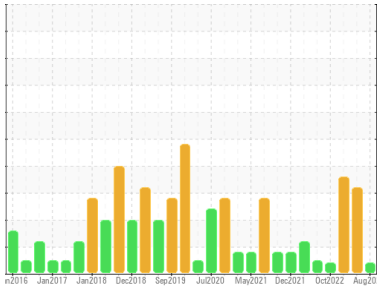
Sample Rating Trend

VIS DEBRIS

Contamination
Moderate concentration of visible dirt/debris present in the oil.

Recommendation
We recommend you service the filters on this component. Resample at the next service interval to monitor. We were unable to perform a particle count due to a high concentration of particles present in this sample.
