Area
[15856]
Machine Id
40-190
Component
Hydraulic System
Fluid
CONOCO MEGAFLOW AW 46 (--- GAL)

Customer Id: MANTUL
Sample No.: WC0818659
Lab Number: 05928751
Test Package: CONST

OIL ANALYSIS REPORT

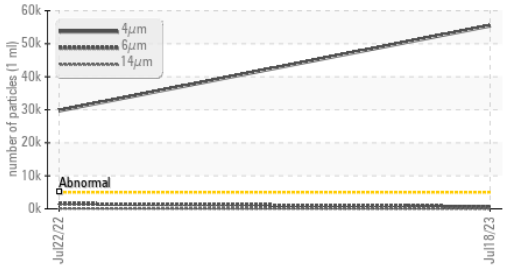
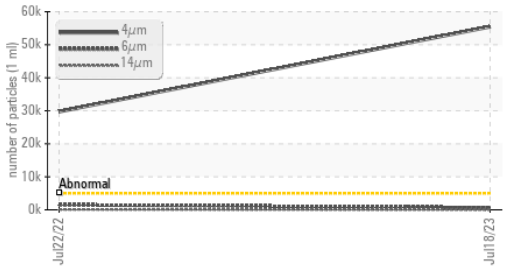
Particle Trend

Contamination
There is a high amount of silt (particulates < 14 microns in size) present in the oil.

FLUID CLEANLINESS		method	limit/base	current	history1	history2
Particles >4µm		ASTM D7647	>5000	▲ **55427**	▲ 29707	---
Particles >6µm		ASTM D7647	>1300	**616**	▲ 1488	---
Particles >14µm		ASTM D7647	>160	**9**	89	---
Particles >21µm		ASTM D7647	>40	**2**	37	---
Particles >38µm		ASTM D7647	>10	**0**	2	---
Particles >71µm		ASTM D7647	>3	**0**	0	---
Oil Cleanliness		ISO 4406 (c)	>19/17/14	▲ **23/16/10**	▲ 22/18/14	---

Recommendation
No corrective action is recommended at this time. Resample at the next service interval to monitor.

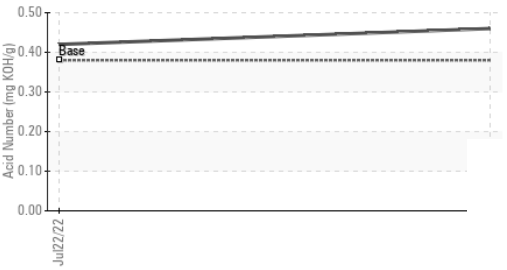
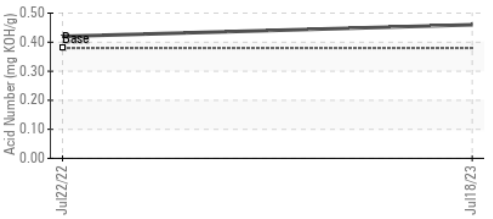
Fluid Condition
The AN level is acceptable for this fluid. The condition of the oil is suitable for further service.

FLUID DEGRADATION		method	limit/base	current	history1	history2
Acid Number (AN)	mg KOH/g	ASTM D8045	0.38	**0.46**	0.42	---

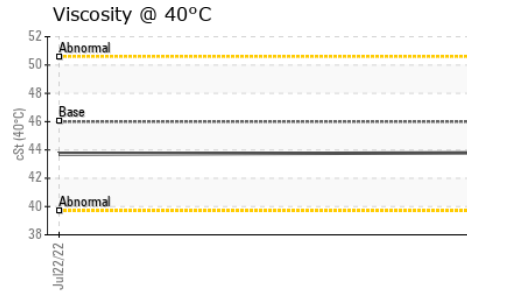
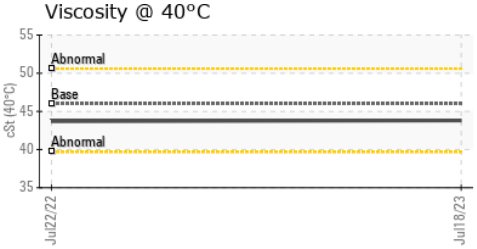
Viscosity @ 40°C

FLUID PROPERTIES		method	limit/base	current	history1	history2
Visc @ 40°C	cSt	ASTM D445	46	**43.8**	43.7	---
