PROBLEM SUMMARY

Area
ENGINE ROOM [PR1375369]
Machine Id
FRICK C09-1 (S/N F0036ZFMNTHAA03)
Component
Refrigeration Compressor
Fluid
FRICK COMPRESSOR OIL #3 (--- PNT)

OIL ANALYSIS REPORT

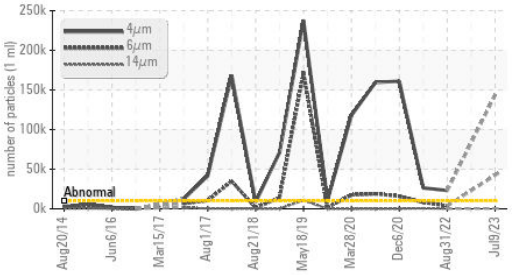
Particle Trend

Contamination
There is a high amount of silt (particulates < 14 microns in size) present in the oil.

FLUID CLEANLINESS		method	limit/base	current	history1	history2
Particles >4µm		ASTM D7647	>10000	▲ **143415**	---	▲ 23136
Particles >6µm		ASTM D7647	>2500	▲ **42418**	---	▲ 3607
Particles >14µm		ASTM D7647	>320	**123**	---	94
Particles >21µm		ASTM D7647	>80	**11**	---	11
Particles >38µm		ASTM D7647	>20	**0**	---	0
Particles >71µm		ASTM D7647	>4	**0**	---	0
Oil Cleanliness		ISO 4406 (c)	>20/18/15	▲ **24/23/14**	---	▲ 22/19/14

Recommendation
Resample at the next service interval to monitor.

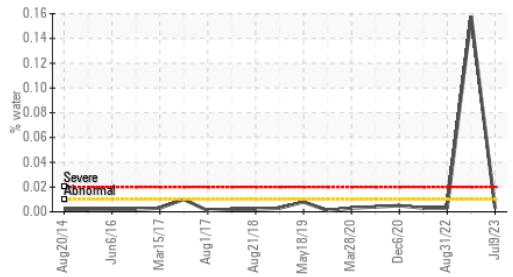
CONTAMINANTS		method	limit/base	current	history1	history2
Silicon	ppm	ASTM D5185m	>15	**0**	<1	<1
Sodium	ppm	ASTM D5185m		**<1**	<1	0
Potassium	ppm	ASTM D5185m	>20	**0**	0	1
Water	%	ASTM D6304	>0.01	**0.003**	▲ 0.158	0.003
ppm Water	ppm	ASTM D6304	>100	**27.8**	▲ 1580	37.8

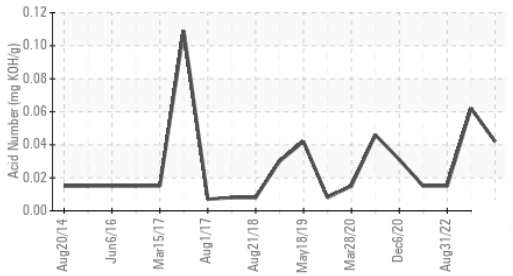
Fluid Condition
The AN level is acceptable for this fluid. The condition of the oil is suitable for further service.

FLUID DEGRADATION		method	limit/base	current	history1	history2
Acid Number (AN)	mg KOH/g	ASTM D974		**0.042**	0.062	0.015

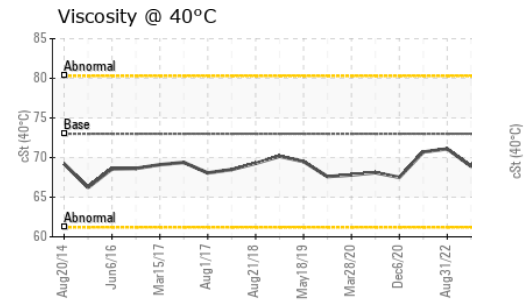
Viscosity @ 40°C

FLUID PROPERTIES		method	limit/base	current	history1	history2
Visc @ 40°C	cSt	ASTM D445	73	**71.5**	68.9	71.1

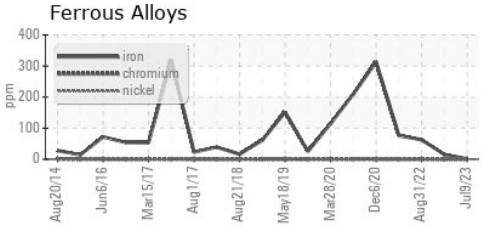
Ferrous Alloys

Wear
All component wear rates are normal.

WEAR METALS		method	limit/base	current	history1	history2
Iron	ppm	ASTM D5185m	>8	**1**	15	▲ 63
Chromium	ppm	ASTM D5185m	>2	**0**	0	0
Nickel	ppm	ASTM D5185m		**0**	0	0
Titanium	ppm	ASTM D5185m		**<1**	0	0
Silver	ppm	ASTM D5185m	>2	**0**	0	<1
Aluminum	ppm	ASTM D5185m	>3	**0**	0	<1
Lead	ppm	ASTM D5185m	>2	**0**	0	0
Copper	ppm	ASTM D5185m	>8	**0**	<1	<1
Tin	ppm	ASTM D5185m	>4	**0**	0	<1
Vanadium	ppm	ASTM D5185m		**<1**	0	0
Cadmium	ppm	ASTM D5185m		**0**	0	0
