Area
PO-4030 [A13000316]
Machine Id
INGERSOLL RAND CBV422799 - FEDEX GROUND KENNESAW
Component
Compressor

OIL ANALYSIS REPORT

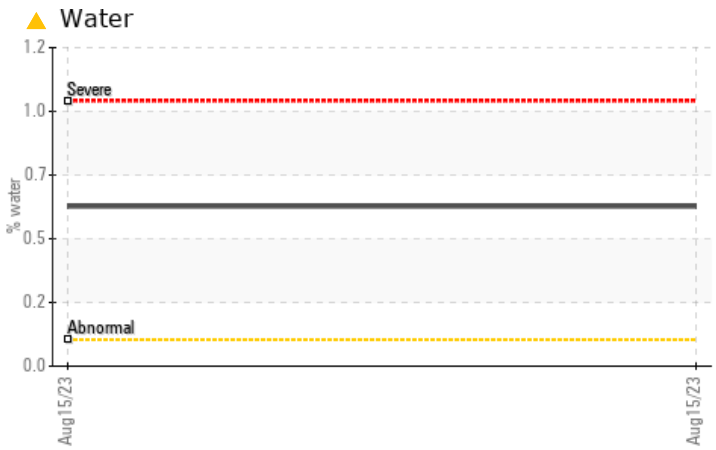
COMPONENT CONDITION SUMMARY

WATER

Sample Status				**ATTENTION**	NORMAL	NORMAL
Water	%	ASTM D6304	>0.1	▲ **0.602**	---	---
ppm Water	ppm	ASTM D6304	>1000	▲ **6020**	---	---
Emulsified Water	scalar	*Visual	>0.1	▲ **0.2%**	NEG	NEG

We advise that you follow the water drain-off procedure for this component. Resample at the next service interval to monitor.

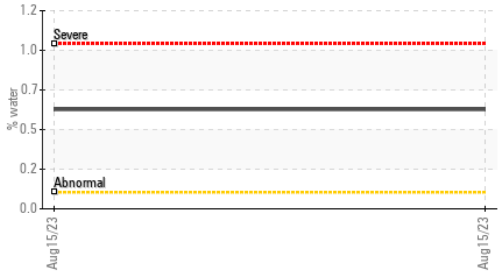
Contamination
There is a moderate concentration of water present in the oil.

CONTAMINANTS		method	limit/base	current	history1	history2
Silicon	ppm	ASTM D5185m	>25	**3**	3	3
Sodium	ppm	ASTM D5185m		**47**	44	47
Potassium	ppm	ASTM D5185m	>20	**7**	<1	2
Water	%	ASTM D6304	>0.1	▲ **0.602**	---	---
ppm Water	ppm	ASTM D6304	>1000	▲ **6020**	---	---

Recommendation
We advise that you follow the water drain-off procedure for this component. Resample at the next service interval to monitor.

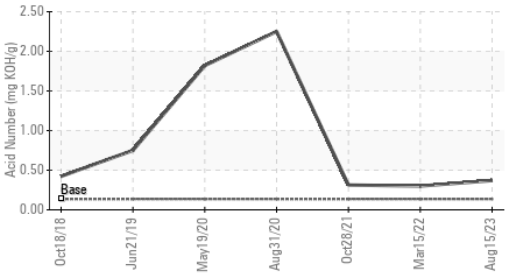
Fluid Condition
The AN level is acceptable for this fluid.

FLUID DEGRADATION		method	limit/base	current	history1	history2
Acid Number (AN)	mg KOH/g	ASTM D8045	0.136	**0.37**	0.30	0.313

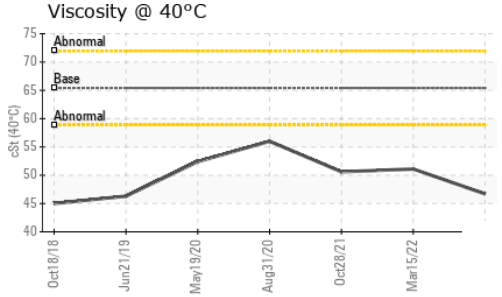
Viscosity @ 40°C

FLUID PROPERTIES		method	limit/base	current	history1	history2
Visc @ 40°C	cSt	ASTM D445	65.42	**46.7**	51.1	50.6
