PROBLEM SUMMARY

Area
TM 6
Machine Id
ROLL TABLE HYD 2
Component
Hydraulic System
Fluid
AW HYDRAULIC OIL ISO 68 (--- GAL)

OIL ANALYSIS REPORT

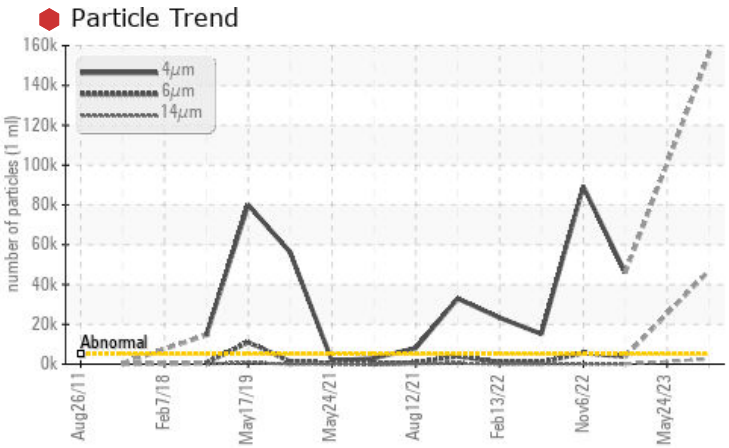
COMPONENT CONDITION SUMMARY

Sample Status				SEVERE	ABNORMAL	SEVERE
Particles >4µm		ASTM D7647	>5000	**155669**	---	46032
Particles >6µm		ASTM D7647	>1300	**46933**	---	3740
Particles >14µm		ASTM D7647	>160	**2544**	---	57
Particles >21µm		ASTM D7647	>40	**504**	---	8
Particles >38µm		ASTM D7647	>10	**20**	---	1
Oil Cleanliness		ISO 4406 (c)	>19/17/14	**24/23/19**	---	23/19/13

We recommend you service the filters on this component if applicable. Resample at the next service interval to monitor.

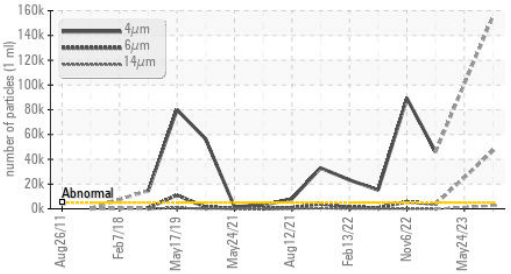
Particle Trend

Contamination
There is a high amount of particulates present in the oil.

FLUID CLEANLINESS	method	limit/base	current	history1	history2
Particles >4µm	ASTM D7647	>5000	**155669**	---	46032
Particles >6µm	ASTM D7647	>1300	**46933**	---	3740
Particles >14µm	ASTM D7647	>160	**2544**	---	57
Particles >21µm	ASTM D7647	>40	**504**	---	8
Particles >38µm	ASTM D7647	>10	**20**	---	1
Particles >71µm	ASTM D7647	>3	**1**	---	0
Oil Cleanliness	ISO 4406 (c)	>19/17/14	**24/23/19**	---	23/19/13

Recommendation
We recommend you service the filters on this component if applicable. Resample at the next service interval to monitor.
