Customer Id: DARDALTX
Sample No.: TO50001738
Lab Number: 05933510
Test Package: IND 2

OIL ANALYSIS REPORT

Area
Thermoforming
Machine Id
Line 3 D Extruder (S/N X-8264)
Component
Bevel Helical Gearbox
Fluid
NOT GIVEN (8 GAL)

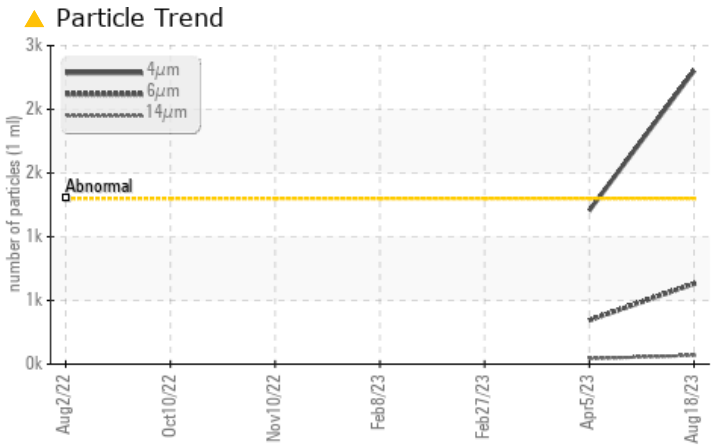
COMPONENT CONDITION SUMMARY

Sample Status				ATTENTION	ATTENTION	NORMAL
Particles >4µm		ASTM D7647	>1300	▲ **2303**	1206	---
Particles >6µm		ASTM D7647	>320	▲ **632**	▲ 345	---
Oil Cleanliness		ISO 4406 (c)	>17/15/13	▲ **18/16/13**	▲ 17/16/13	---

Contamination
There is a moderate amount of silt (particulates < 14 microns in size) present in the oil.

No corrective action is recommended at this time.
Resample at the next service interval to monitor. (
Customer Sample Comment: BC)

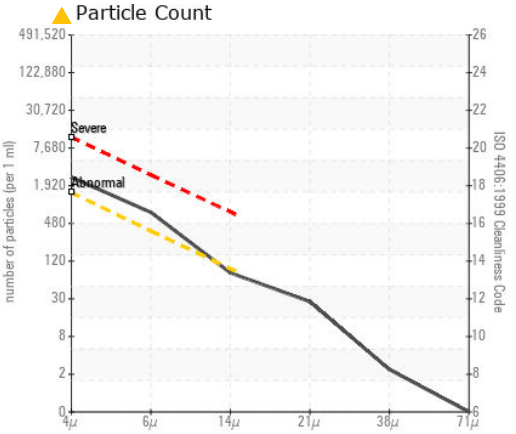
Particle Count

FLUID CLEANLINESS		method	limit/base	current	history1	history2
Particles >4µm		ASTM D7647	>1300	▲ **2303**	1206	---
Particles >6µm		ASTM D7647	>320	▲ **632**	▲ 345	---
Particles >14µm		ASTM D7647	>80	**69**	43	---
Particles >21µm		ASTM D7647	>20	**24**	16	---
Particles >38µm		ASTM D7647	>4	**2**	1	---
Particles >71µm		ASTM D7647	>3	**0**	0	---
Oil Cleanliness		ISO 4406 (c)	>17/15/13	▲ **18/16/13**	▲ 17/16/13	---

Recommendation
No corrective action is recommended at this time. Resample at the next service interval to monitor. (Customer Sample Comment: BC)
