PROBLEM SUMMARY

Area
IRON STAR [200006142]
Machine Id
59WEA88333
Component
Wind Turbine Gearbox
Fluid
NOT GIVEN (--- LTR)

OIL ANALYSIS REPORT

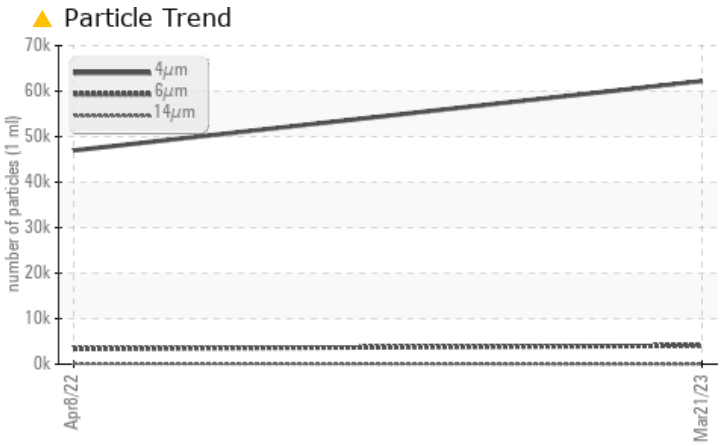
COMPONENT CONDITION SUMMARY

Sample Status				**ABNORMAL**	ABNORMAL	---
Particles >6µm		ASTM D7647	>320	▲ **4054**	▲ 3341	---
Oil Cleanliness		ISO 4406 (c)	>--/15/12	▲ **23/19/12**	▲ 23/19/14	---

Contamination
There is a high amount of silt (particulates < 14 microns in size) present in the oil.

No corrective action is recommended at this time.
Resample at the next service interval to monitor.

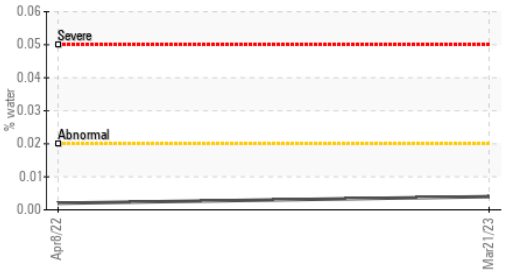
CONTAMINANTS		method	limit/base	current	history1	history2
Silicon	ppm	ASTM D5185m	>+15	**11**	11	---
Sodium	ppm	ASTM D5185m		**0**	2	---
Potassium	ppm	ASTM D5185m	>20	**2**	0	---
Water	%	ASTM D6304	>0.02	**0.004**	0.002	---
ppm Water	ppm	ASTM D6304	>200	**41.0**	21.0	---

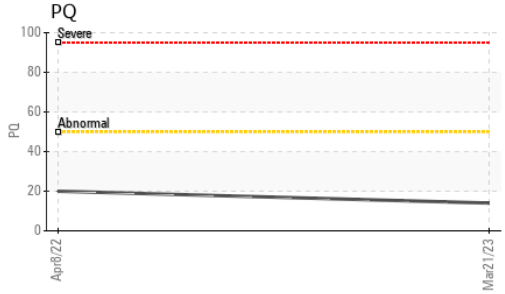
WEAR METALS		method	limit/base	current	history1	history2
PQ		ASTM D8184	>50	**14**	20	---
Iron	ppm	ASTM D5185m	>30	**15**	12	---
Chromium	ppm	ASTM D5185m	>3	**0**	0	---
Nickel	ppm	ASTM D5185m	>3	**0**	<1	---
Titanium	ppm	ASTM D5185m	>10	**0**	0	---
Silver	ppm	ASTM D5185m		**0**	<1	---
Aluminum	ppm	ASTM D5185m	>30	**0**	0	---
Lead	ppm	ASTM D5185m	>15	**<1**	0	---
Copper	ppm	ASTM D5185m	>10	**<1**	0	---
Tin	ppm	ASTM D5185m	>10	**0**	<1	---
Vanadium	ppm	ASTM D5185m		**0**	0	---
Cadmium	ppm	ASTM D5185m		**0**	0	---

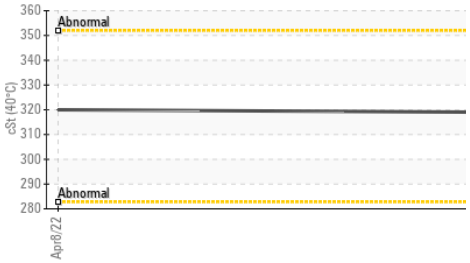
Viscosity @ 40°C

FLUID PROPERTIES		method	limit/base	current	history1	history2
Visc @ 40°C	cSt	ASTM D445		**319**	320	---

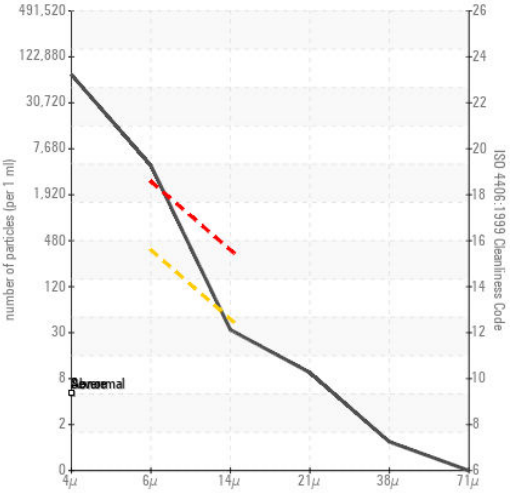
Particle Count

FLUID CLEANLINESS		method	limit/base	current	history1	history2
Particles >4µm		ASTM D7647		**62216**	46968	---
Particles >6µm		ASTM D7647	>320	▲ **4054**	▲ 3341	---
Particles >14µm		ASTM D7647	>40	**29**	▲ 133	---
Particles >21µm		ASTM D7647	>10	**8**	▲ 33	---
Particles >38µm		ASTM D7647	>3	**1**	2	---
Particles >71µm		ASTM D7647	>3	**0**	0	---
Oil Cleanliness		ISO 4406 (c)	>--/15/12	▲ **23/19/12**	▲ 23/19/14	---

Recommendation
No corrective action is recommended at this time. Resample at the next service interval to monitor.

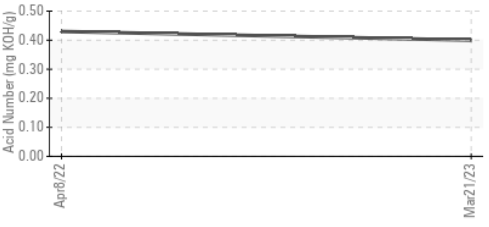
Fluid Condition
The AN level is acceptable for this fluid. The condition of the oil is suitable for further service.

FLUID DEGRADATION		method	limit/base	current	history1	history2
Acid Number (AN)	mg KOH/g	ASTM D8045		**0.40**	0.43	---
