Customer Id: KRADAV
Sample No.: USPM29385
Lab Number: 05933681
Test Package: IND 2

OIL ANALYSIS REPORT

Machine Id
C6 TUMBLER
Component
Pump
Fluid
USPI VAC 100 (--- LTR)

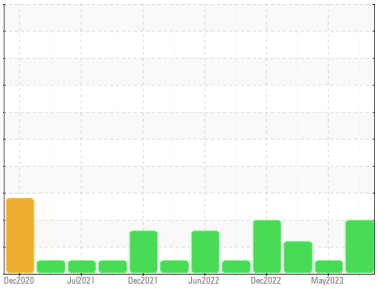
Sample Rating Trend

Sample Status				**ABNORMAL**	NORMAL	ABNORMAL
Particles >4µm		ASTM D7647	>10000	▲ **44526**	1944	9120
Particles >6µm		ASTM D7647	>2500	▲ **25186**	1612	▲ 6543
Particles >14µm		ASTM D7647	>640	▲ **2151**	441	▲ 871
Particles >21µm		ASTM D7647	>160	▲ **165**	53	71
Oil Cleanliness		ISO 4406 (c)	>20/18/16	▲ **23/22/18**	18/18/16	▲ 20/20/17

We recommend you service the filters on this component. Resample at the next service interval to monitor.

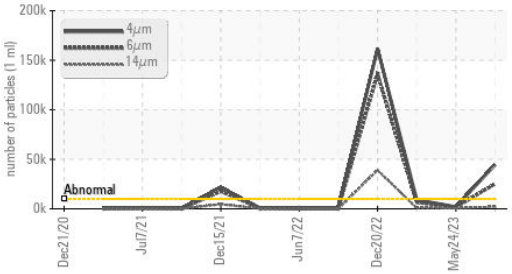
Particle Trend

Contamination
There is a high amount of particulates present in the oil.

FLUID CLEANLINESS		method	limit/base	current	history1	history2
Particles >4µm		ASTM D7647	>10000	▲ **44526**	1944	9120
Particles >6µm		ASTM D7647	>2500	▲ **25186**	1612	▲ 6543
Particles >14µm		ASTM D7647	>640	▲ **2151**	441	▲ 871
Particles >21µm		ASTM D7647	>160	▲ **165**	53	71
Particles >38µm		ASTM D7647	>40	**1**	0	3
Particles >71µm		ASTM D7647	>10	**0**	0	2
Oil Cleanliness		ISO 4406 (c)	>20/18/16	▲ **23/22/18**	18/18/16	▲ 20/20/17

Recommendation
We recommend you service the filters on this component. Resample at the next service interval to monitor.
