PROBLEM SUMMARY

Area
Building 12
Machine Id
Cone 2B
Component
Bulk Tank Lube System
Fluid
MOBIL MOBILGEAR 600 XP 320 (--- GAL)

OIL ANALYSIS REPORT

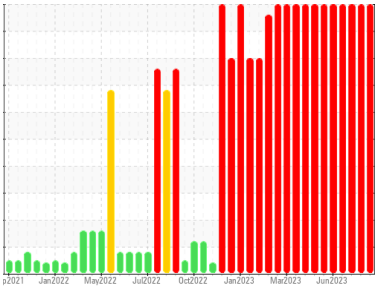
Sample Rating Trend

WEAR

Sample Status				**SEVERE**	SEVERE	SEVERE
Iron	ppm	ASTM D5185m	>20	**295**	221	161
Aluminum	ppm	ASTM D5185m	>20	**40**	35	29
Lead	ppm	ASTM D5185m	>20	**177**	115	103
Copper	ppm	ASTM D5185m	>20	**1035**	679	482
Tin	ppm	ASTM D5185m	>20	**105**	65	49
Silicon	ppm	ASTM D5185m	>15	**112**	99	87

We advise that you check all areas where dirt can enter the system. We advise that you perform a filter service, and use off-line filtration to improve the cleanliness of the system fluid. We advise that you inspect for the source(s) of wear. We recommend an early resample to monitor this condition.

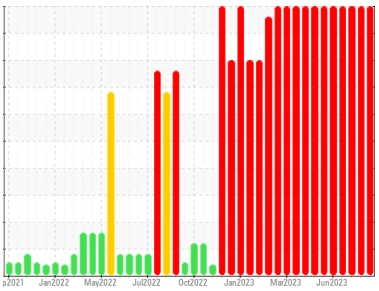
Sample Rating Trend

WEAR

Wear
Generally an abnormal to severe rate of wear throughout the component.

Contamination
Elemental levels of silicon (Si) and aluminum (Al) indicate alumina-silicate (coarse dirt) ingress.

Fluid Condition
The AN level is acceptable for this fluid. The oil is no longer serviceable due to the presence of contaminants.

Recommendation
We advise that you check all areas where dirt can enter the system. We advise that you perform a filter service, and use off-line filtration to improve the cleanliness of the system fluid. We advise that you inspect for the source(s) of wear. We recommend an early resample to monitor this condition.
