PROBLEM SUMMARY

Area
MOBIL ARTIC 300
Machine Id
3/FB04134 (S/N MK4CWRV255/16531918)
Component
Refrigeration Compressor
Fluid
MOBIL GARGOYLE ARTIC 300 (165 GAL)

OIL ANALYSIS REPORT

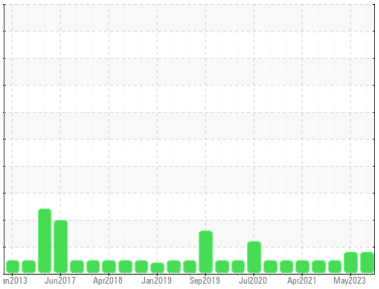
Sample Rating Trend

Sample Status				ABNORMAL	ATTENTION	NORMAL
Particles >6µm		ASTM D7647	>1300	▲ **3375**	▲ 1605	383
Oil Cleanliness		ISO 4406 (c)	>20/17/14	▲ **20/19/14**	▲ 20/18/14	18/16/11

No corrective action is recommended at this time.
Resample at the next service interval to monitor.

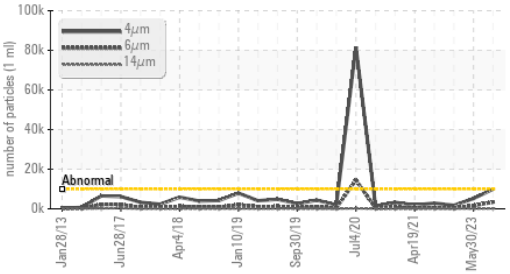
Particle Trend

There is a high amount of silt (particulates < 14 microns in size) present in the oil.

FLUID CLEANLINESS		method	limit/base	current	history1	history2
Particles >4µm		ASTM D7647	>10000	**9956**	5195	1749
Particles >6µm		ASTM D7647	>1300	**▲ 3375**	▲ 1605	383
Particles >14µm		ASTM D7647	>160	**151**	91	18
Particles >21µm		ASTM D7647	>40	**22**	18	1
Particles >38µm		ASTM D7647	>10	**1**	2	0
Particles >71µm		ASTM D7647	>3	**0**	1	0
Oil Cleanliness		ISO 4406 (c)	>20/17/14	**▲ 20/19/14**	▲ 20/18/14	18/16/11

No corrective action is recommended at this time. Resample at the next service interval to monitor.
