Area
[6043126]
Machine Id
BD1744 (S/N CP005774)
Component
Compressor
Fluid
TULCO LUBSOIL LPG WS 150 (--- GAL)

Customer Id: EOGMID
Sample No.: TO60001255
Lab Number: 05936663
Test Package: IND 2

OIL ANALYSIS REPORT

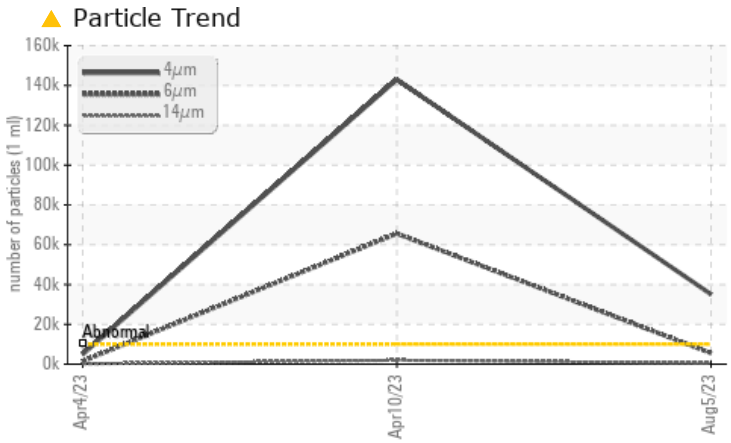
COMPONENT CONDITION SUMMARY

Sample Status				ABNORMAL	ABNORMAL	ATTENTION
Particles >4µm		ASTM D7647	>10000	▲ **35081**	▲ 143010	4950
Particles >6µm		ASTM D7647	>1300	▲ **5527**	▲ 65577	▲ 1474
Particles >14µm		ASTM D7647	>320	▲ **485**	▲ 1961	153
Particles >21µm		ASTM D7647	>80	▲ **161**	▲ 186	46
Oil Cleanliness		ISO 4406 (c)	>20/17/15	▲ **22/20/16**	▲ 24/23/18	▲ 19/18/14

Contamination
There is a high amount of particulates present in the oil.

No corrective action is recommended at this time. Oil and filter change at the time of sampling has been noted. Resample at the next service interval to monitor.

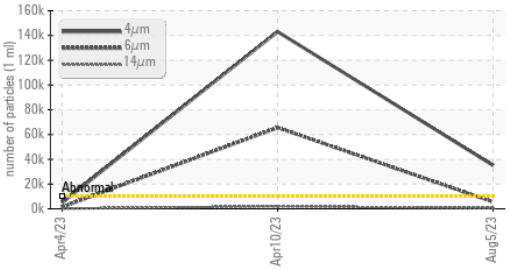
Particle Trend

FLUID CLEANLINESS		method	limit/base	current	history1	history2
Particles >4µm		ASTM D7647	>10000	▲ **35081**	▲ 143010	4950
Particles >6µm		ASTM D7647	>1300	▲ **5527**	▲ 65577	▲ 1474
Particles >14µm		ASTM D7647	>320	▲ **485**	▲ 1961	153
Particles >21µm		ASTM D7647	>80	▲ **161**	▲ 186	46
Particles >38µm		ASTM D7647	>20	**10**	3	2
Particles >71µm		ASTM D7647	>4	**0**	0	0
Oil Cleanliness		ISO 4406 (c)	>20/17/15	▲ **22/20/16**	▲ 24/23/18	▲ 19/18/14
