PROBLEM SUMMARY

OIL ANALYSIS REPORT

Area
COMPRESSOR STATIONS/RED HILLS EAST AREA
Machine Id
ABU (S/N 5329X5976)
Component
Compressor
Fluid
TULCO LUBSOIL LPG WS 150 (--- GAL)

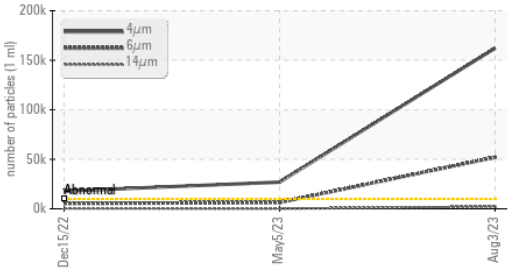
Particle Trend

Contamination
There is a high amount of particulates present in the oil.

FLUID CLEANLINESS		method	limit/base	current	history1	history2
Particles >4µm		ASTM D7647	>10000	▲ **162162**	▲ 26928	▲ 17913
Particles >6µm		ASTM D7647	>1300	▲ **51971**	▲ 6341	▲ 5350
Particles >14µm		ASTM D7647	>320	▲ **2187**	102	▲ 331
Particles >21µm		ASTM D7647	>80	▲ **362**	16	59
Particles >38µm		ASTM D7647	>20	**11**	1	2
Particles >71µm		ASTM D7647	>4	**0**	0	1
Oil Cleanliness		ISO 4406 (c)	>20/17/15	▲ **25/23/18**	▲ 22/20/14	▲ 21/20/16

Recommendation
We recommend you service the filters on this component. Resample at the next service interval to monitor.
