PROBLEM SUMMARY

Area
Extrusion
Machine Id
Press 2 Press Hydraulic Unit (S/N 70227)
Component
Hydraulic System
Fluid
AW HYDRAULIC OIL ISO 46 (2500 GAL)

Customer Id: WESCARTEX
Sample No.: RP0024725
Lab Number: 05938264
Test Package: IND 2

OIL ANALYSIS REPORT

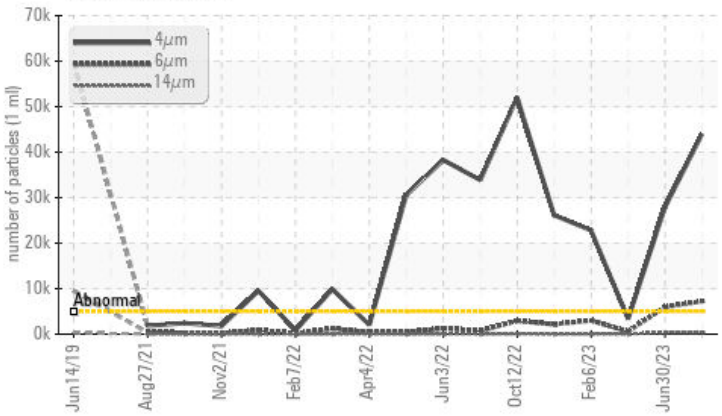
Particle Trend

Sample Status				ABNORMAL	ABNORMAL	NORMAL
Particles >4µm		ASTM D7647	>5000	▲ **43960**	▲ 27907	3353
Particles >6µm		ASTM D7647	>1300	▲ **7239**	▲ 5944	599
Particles >14µm		ASTM D7647	>160	▲ **296**	▲ 362	33
Particles >21µm		ASTM D7647	>40	▲ **66**	▲ 90	9
Oil Cleanliness		ISO 4406 (c)	>19/17/14	▲ **23/20/15**	▲ 22/20/16	19/16/12

Contamination
There is a high amount of particulates present in the oil.

We recommend you service the filters on this component. Resample at the next service interval to monitor.

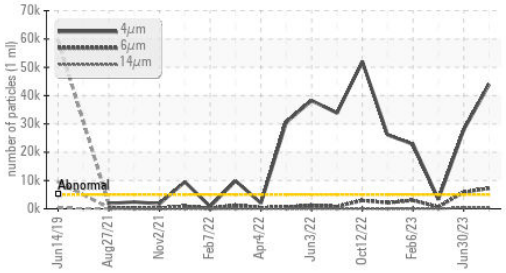
Particle Trend

FLUID CLEANLINESS		method	limit/base	current	history1	history2
Particles >4µm		ASTM D7647	>5000	▲ **43960**	▲ 27907	3353
Particles >6µm		ASTM D7647	>1300	▲ **7239**	▲ 5944	599
Particles >14µm		ASTM D7647	>160	▲ **296**	▲ 362	33
Particles >21µm		ASTM D7647	>40	▲ **66**	▲ 90	9
Particles >38µm		ASTM D7647	>10	**1**	4	0
Particles >71µm		ASTM D7647	>3	**0**	0	0
Oil Cleanliness		ISO 4406 (c)	>19/17/14	▲ **23/20/15**	▲ 22/20/16	19/16/12

Recommendation
We recommend you service the filters on this component. Resample at the next service interval to monitor.
