Machine Id
KAESER SM 7.5 6259582 (S/N 1027)
Component
Compressor
Fluid
KAESER SIGMA (OEM) M-460 (--- QTS)

Customer Id: CASFORCO
Sample No.: KCPA003856
Lab Number: 05938316
Test Package: IND 2

OIL ANALYSIS REPORT

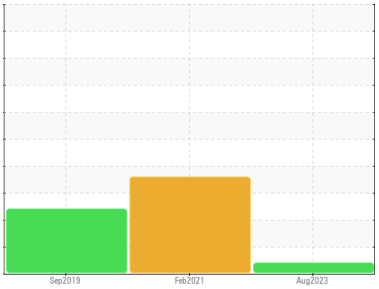
Sample Rating Trend

VIS DEBRIS

Sample Status				**ABNORMAL**	ABNORMAL	ABNORMAL
Debris	scalar	*Visual	NONE	▲ **MODER**	▲ MODER	▲ MODER

No corrective action is recommended at this time. Oil and filter change at the time of sampling has been noted. Resample at the next service interval to monitor. We were unable to perform a particle count due to a high concentration of particles present in this sample.

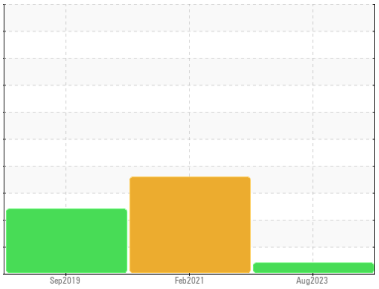
Sample Rating Trend

VIS DEBRIS

Contamination
Moderate concentration of visible dirt/debris present in the oil.

Recommendation
No corrective action is recommended at this time. Oil and filter change at the time of sampling has been noted. Resample at the next service interval to monitor. We were unable to perform a particle count due to a high concentration of particles present in this sample.

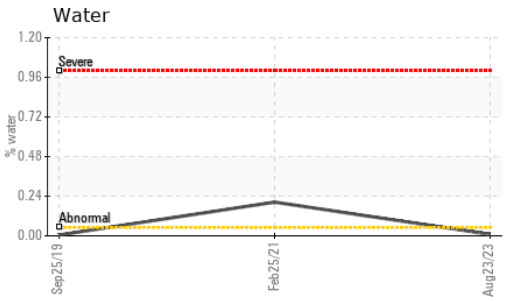
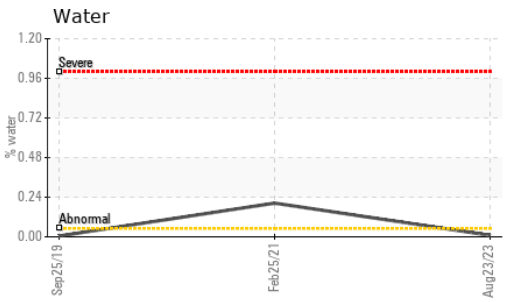
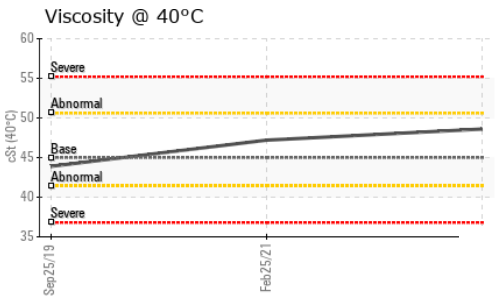
SAMPLE IMAGES	method	limit/base	current	history1	history2
Color					
Bottom

VISUAL		method	limit/base	current	history1	history2
White Metal	scalar	*Visual	NONE	**NONE**	NONE	NONE
Yellow Metal	scalar	*Visual	NONE	**NONE**	NONE	NONE
Precipitate	scalar	*Visual	NONE	**NONE**	NONE	NONE
Silt	scalar	*Visual	NONE	**NONE**	NONE	NONE
Debris	scalar	*Visual	NONE	▲ **MODER**	▲ MODER	▲ MODER
Sand/Dirt	scalar	*Visual	NONE	**NONE**	NONE	NONE
Appearance	scalar	*Visual	NORML	**NORML**	NORML	NORML
Odor	scalar	*Visual	NORML	**NORML**	NORML	NORML
Emulsified Water	scalar	*Visual	>0.05	**NEG**	▲ 0.2%	NEG
Free Water	scalar	*Visual		**NEG**	▲ 2.0	NEG
