Customer Id: TECGRENC
Sample No.: WC0844311
Lab Number: 05939066
Test Package: PLANT

OIL ANALYSIS REPORT

Machine Id
49262082 (S/N 13381)
Component
Hydraulic System
Fluid
MOBIL DTE 24 (--- GAL)

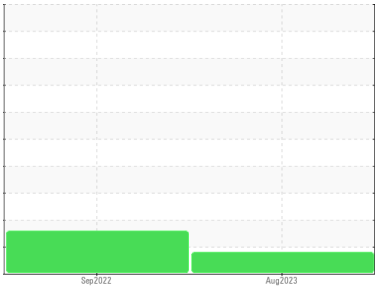
Sample Rating Trend

Sample Status				**ABNORMAL**	ABNORMAL	---
Copper	ppm	ASTM D5185m	>50	▲ **101**	▲ 75	---

No corrective action is recommended at this time. Resample at the next service interval to monitor.The copper level is abnormal. There is a high amount of silt (particulates < 14 microns in size) present in the oil. The AN level is acceptable for this fluid. The condition of the oil is acceptable for the time in service.

No corrective action is recommended at this time.
Resample at the next service interval to monitor.

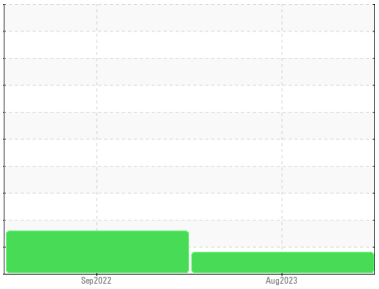
Sample Rating Trend

▲ Wear
The copper level is abnormal. All other component wear rates are normal.

Contamination
There is no indication of any contamination in the oil. The amount and size of particulates present in the system are acceptable.

Fluid Condition
The AN level is acceptable for this fluid. The condition of the oil is suitable for further service.

▲ Recommendation
No corrective action is recommended at this time. Resample at the next service interval to monitor.
