Area
Evp Island
Machine Id
GOULDS #1 I LST Transfer Pump 0314
Component
Pump Roller Bearing
Fluid
MOBIL SHC 626 (2 QTS)

Customer Id: GRAMAC
Sample No.: WC0824338
Lab Number: 05939094
Test Package: PLANT

OIL ANALYSIS REPORT

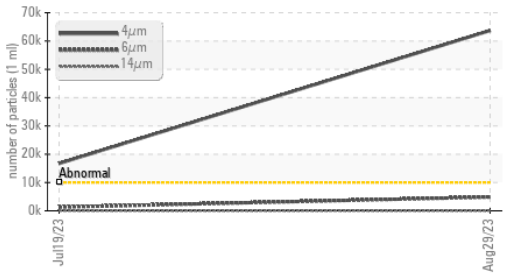
Particle Trend

There is a moderate amount of silt (particulates < 14 microns in size) present in the oil.

FLUID CLEANLINESS		method	limit/base	current	history1	history2
Particles >4µm		ASTM D7647	>10000	▲ **63710**	▲ 16734	---
Particles >6µm		ASTM D7647	>2500	▲ **4864**	1297	---
Particles >14µm		ASTM D7647	>160	**42**	26	---
Particles >21µm		ASTM D7647	>40	**13**	6	---
Particles >38µm		ASTM D7647	>10	**1**	0	---
Particles >71µm		ASTM D7647	>3	**0**	0	---
Oil Cleanliness		ISO 4406 (c)	>20/18/14	▲ **23/19/13**	▲ 21/17/12	---

The oil change at the time of sampling has been noted. We recommend you service the filters on this component. We recommend an early resample to monitor this condition. Analytical Ferrography: Results suggest that the condition of this system has deteriorated from the previous sample, with an increase in the contamination volume and commensurate increase in the amount of ferrous wear that is present. It is strongly recommended to investigate the source of contamination and repair it as soon as possible, and once repaired clean the lubricant with filtration if possible. If a fluid change is the only option to remove the debris in this sump, a flush is recommended, using prefiltered lubricant.

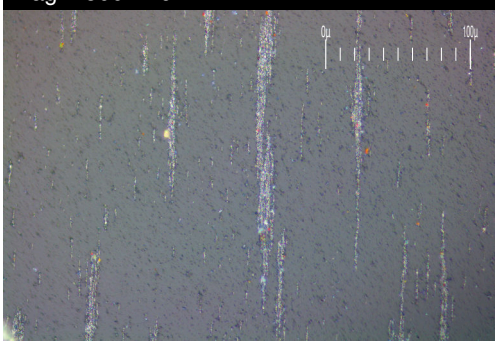
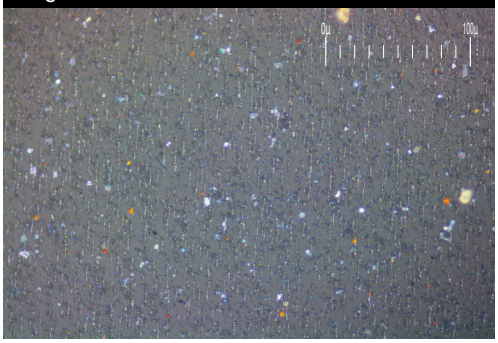
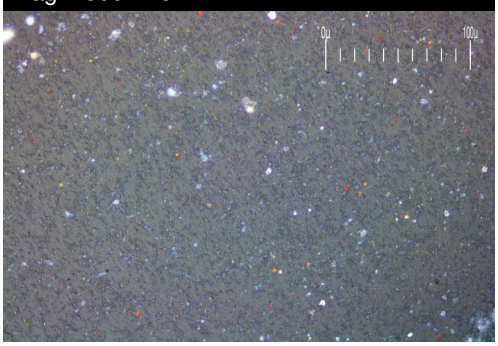
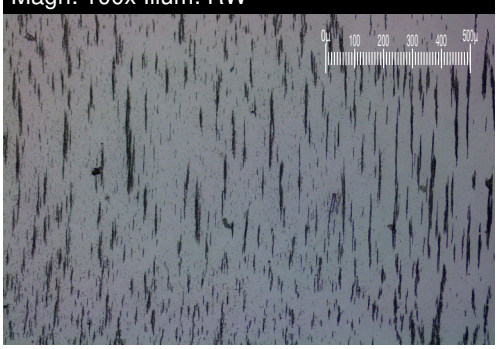
Wear particle analysis indicates that the ferrous rubbing particles are abnormal.

The oil change at the time of sampling has been noted. We recommend you service the filters on this component. We recommend an early resample to monitor this condition. Analytical Ferrography: Results suggest that the condition of this system has deteriorated from the previous sample, with an increase in the contamination volume and commensurate increase in the amount of ferrous wear that is present. It is strongly recommended to investigate the source of contamination and repair it as soon as possible, and once repaired clean the lubricant with filtration if possible. If a fluid change is the only option to remove the debris in this sump, a flush is recommended, using prefiltered lubricant.
